## TEST CERTIFICATE

Site Number	<b>840-Emirates Auctions</b>	Transaction Date	<b>30 Aug 2022, 11:06:41</b>
Transaction Number	<b>26734239 (CC10008)</b>	Queue Number	<b>312309</b>

Chassis Number	<b>1GCEK14T76Z285214</b>
Engine Number	
Vehicle Class	<b>Car</b>
Manufacturer	<b>Chevrolet</b>
Model	<b>Silverado</b>
Model Year	<b>2006</b>
Color	<b>Brown</b>
Mileage	<b>295553 Km</b>
Fuel Type	<b>Petrol</b>
No. Of Cylinders	<b>8</b>
Specification	<b>GCC Specification</b>

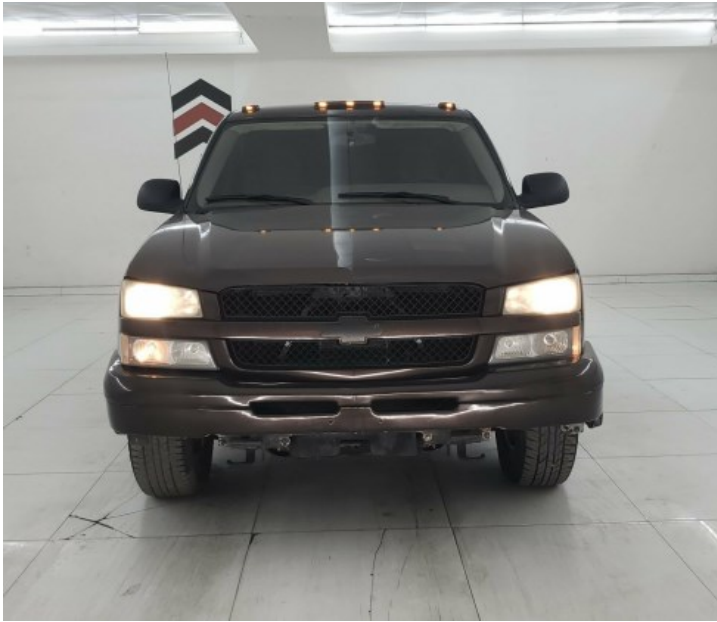
DEFECT	REMARKS	
<b>01 Engine Condition</b>		<b>المحرك</b>
01.A Mount	MOUNT RUBBER CRACKED	كرسي
01.B Visual Engine Condition	OIL LEAK REFITED	حالة المحرك النظري
01.C Smoke	WHITE SMOKE	دخان
<b>02 Interior Condition</b>		<b>الحالة الداخليه</b>
02.A AC Condition	OK & GRILL DAMAGED	المكيف
02.B Dash Board	PORTION CRACKED	لوحة القيادة
02.C Steering Wheel and control buttons	WORN OUT	عجلة القيادة وازرار التحكم
02.D Door Panel	PORTION LOOSE	لوحة بطانة الباب
02.E Mirror	ADJUSTMENT NOT WORKING	المرابيا
<b>03 Tires and Rims Condition</b>		<b>الاطارات</b>
03.A Front Tyre	BOTH SIDE 2021	الاطار الامامي
03.B Rear Tyre	BOTH SIDE 2021	الاطار الخلفي
03.C Spare Tire &Tools	SPARE TIRE MISSING	الاطار الاحتياطي و العدة
<b>04 Suspension System</b>		<b>ممتص الصدمات</b>
04.A Arms	LOWER ARM CONTROL BUSHES CUT	ازرع

DEFECT	REMARKS	
04.B Ball Joint	BOOT CUT	مفصل كروي
04.C Leaf Spring	BUSHES WORN OUT	
04.D Other	STABLIZER LINK BOOT CUT	اخرى
<b>05 Chassis Condition</b>		<b>الشاسي</b>

05.A Chassis	FRONT RIGHT SIDE BEND ,CHASSIS FRAME COMPLETELY THICK RUST PROOFED PORTION RUSTY ,	الشاسيه
05.B Chassis Number	VIN CHECKED ON WINDSHIELD , STICKER FADED	رقم القاعدة
<b>06 Transmission Condition</b>		<b>الجير</b>

06.A Visual Gear Box Condition	OIL LEAK REFITTED	حالة الجير النظرى
06.B Gear Box Mount	MOUNT RUBBER CUT	كرسي الجير
06.C Road Test	NOT CHECKED	فحص علي الطريق
<b>07 Body</b>		<b>جسم المركبة</b>

07.A Paint	BODY TOTALLY REPAINTED PORTION REPAIRED , MINOR DENTS SCRATCHES	الصبغ
07.B Floor	FLOOR PORTION BOTH SIDE RUNNING BOARD REPAIRED, THICK RUST PROOFED	الارضية

07.C Pillars	BOTH SIDE B/PILLAR OUTER REPAIRED REPAINTED	القوائم
<b>08 Exhaust System</b>		<b>نظام العادم</b>
08.A Modification	MODIFIED NOISY	تعديلات
