TEST CERTIFICATE

Site Number	840-Emirates Auctions	Transaction Date	23 Dec 2021, 18:13:35
Transaction Number	53759595 (CC10006)	Queue Number	312309

Chassis Number	5TFRM5F15HX119173
Engine Number	
Vehicle Class	Heavy
Manufacturer	Toyota
Model	Tundra
Model Year	2017
Color	Red
Mileage	20685 Miles
Fuel Type	Petrol
No. Of Cylinders	8
Specification	USA Imported

Test Certificate

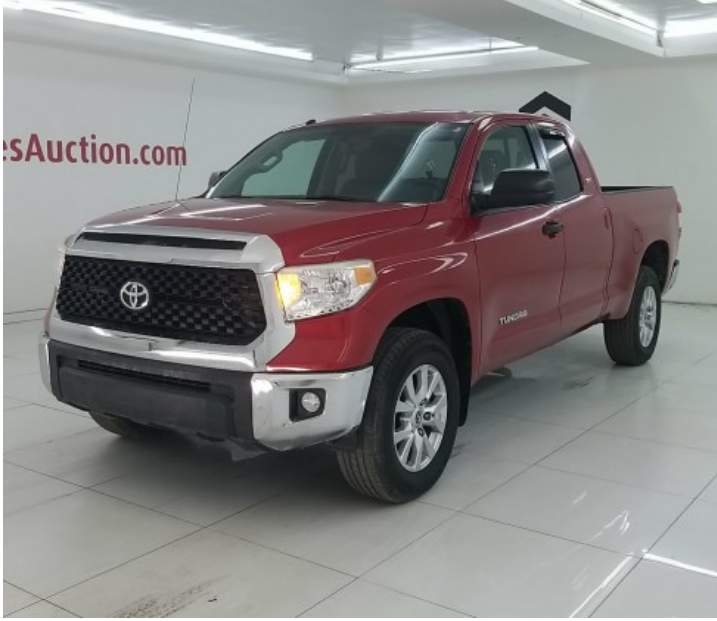
DEFECT	REMARKS	
01 Interior Condition		الحاله الداخليه
01.A Air Bag	BOTH SIDE AIR BAG DAMAGED	وسائد هوائية
01.B Roof Ceiling	PORTION LOOSE	بطانه السقف
01.C AC Condition	OK	المكيف
01.D Mirror	CENTER MIRROR LOOSE	المرايا
02 Body		جسم المركبة
02.A Pillars	LEFT SIDE C/PILLAR ,ROCKER PANEL REPAIRED	القوائم
02.B Paint	BODY PORTION REPAINTED,PORTION REPAIRED	الصبغ
02.C Doors	LEFT SIDE BOTH DOOR PORTION REPAINTED,PORTION REPAIRED	أبواب
02.D Fenders	FRONT LEFT SIDE FENDER REPAINTED&REAR CARRIER BOX REPAINTED,PORTION REPAIRED	مدكار
02.E Trunk	REPAINTED,PORTION REPAIRED	صندوق
02.F Rusty	UNDER BODY PARTS, SUSPENSION , CHASSIS GETTING MINOR RUSTY	صدأ
02.G Sign of side accident		وجود مؤشر لحادث في الجانب
02.H Floor	BODY MOUNT MISALIGN	الارضية
03 Lights		الاضاءة

DEFECT	REMARKS	
03.A Tail Light	REAR RIGHT SIDE LENS BROKEN	الانارة
04 Tires and Rims Condition		الاطارات
04.A Front Tyre	BOTH SIDE 2017 MINOR CRACKED	الاطار الامامي
04.B Rear Tyre	BOTH SIDE 2017/2018	الاطار الخلفي
04.C Rims Condition	RIMS HAVE MINOR SCRATCHES	حالة الجنوط
05 Wipers and Arms		المساحات
05.A Wiper Arm &Blade	WORN OUT	ازرع المساحات والشفرات
06 Seats Condition		المقاعد
06.A Seat Belt	OK	حزام الأمان
06.B Seat Condition	OK	حالة المقاعد
07 Chassis Condition		الشاسي
07.A Chassis	REAR BOTH SIDE MIDDLE CHASSIS HEATED REPAIRED&RIGHT SIDE LEAF SPRING MOUNT REPAIRED&MIDDLE OUTER MINOR DENT	الشاسيه
08 Engine Condition		المحرك
08.A Engine Condition	OK	حالة المحرك
09 Transmission Condition		الجير
09.A Road Test	NOT CHECK	فحص علي الطريق
09.B Gear Box	OK	الجير
09.C Propeller Shaft	CENTER PROPELLER SHAFT BEARING RUBBER WORNOUT	ناقل الحركة
