## TEST CERTIFICATE

Chassis Number	<b>JTJBM7FX7C5048030</b>
Engine Number	
Vehicle Class	<b>Car</b>
Manufacturer	<b>Lexus</b>
Model	<b>GX 460</b>
Model Year	<b>2012</b>
Color	<b>White</b>
Mileage	<b>119092 Miles</b>
Fuel Type	<b>Petrol</b>
No. Of Cylinders	<b>8</b>
Specification	<b>USA Imported</b>

# Test Certificate

Certificate Number :	5-TAS-2022-17277363		
Inspection Date :	26-07-2022		
Certificate Print Date :	26-07-2022		
Services :	Registration Test		
Vehicle Testing Partner :	Tasjeel		
Vehicle Testing Center :	Tasjeel Al Aweer		
Total Time Taken :	7 min 34 sec		
Appointment Ref Number :	--		
Start Time :	12:50	End Time :	12:58
Lane :	03	Token No. :	142
Attempt :	1	Prints No. :	1

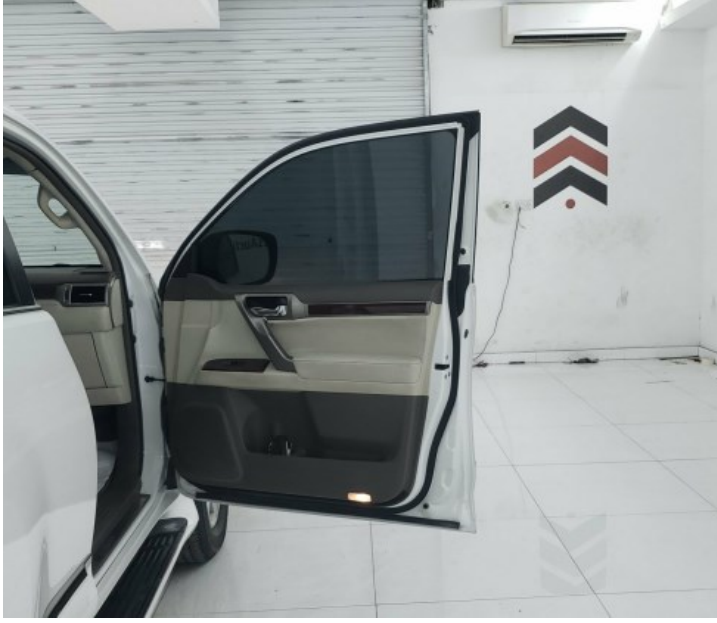
DEFECT	REMARKS	
<b>01 Transmission Condition</b>		<b>الجير</b>
01.A Road Test	NOT CHECK	فحص علي الطريق
01.B Visual Gear Box Condition	OK	حالة الجير النظرى
<b>02 Body</b>		<b>جسم المركبة</b>
02.A Paint	BODY PORTION REPAINTED,PORION REPAIRED,MINOR DENT,SCRATCHES	الصبغ
02.B Pillars	REAR RIGHT SIDE PILLAR OUTER PANEL REPAIRED, REPAINTED	القوائم
02.C Sign of side accident		وجود مؤشر لحادث في الجانب
02.D Sign of front accident		وجود مؤشر لحادث في المقدمة
02.E Rusty	UNDER BODY PARTS, SUSPENSION ,CHASSIS FRAME GETTING RUSTY	صدأ
02.F Other	FRONT FENDER FRAME, BUMPER FRAME, RADITOR SUPPORT ,RIGHT SIDE WHEEL ARCH REPAIRED	اخرى
02.G Fenders	FRONT BOTH SIDE , REAR RIGHT SIDE PORTION REPAIRED, REPAINTED, REFITTED	مدكار
02.H Doors	RIGHT SIDE BOTH PORTION REPAIRED , REPAINTED, REFITTED	أبواب
02.I Bonnet	PORTION REPAIRED,REPAINTED & REFITTED	غطاء المحرك

DEFECT	REMARKS	
<b>03 Interior Condition</b>		<b>الحاله الداخليه</b>
03.A Air Bag	DAMAGED	وسائد هوائية
03.B AC Condition	OK	المكيف
<b>04 Tires and Rims Condition</b>		<b>الاطارات</b>
04.A Front Tyre	BOT SIDE 2019	الاطار الامامي
04.B Rear Tyre	BOT SIDE 2019	الاطار الخلفي
<b>05 Chassis Condition</b>		<b>الشاصي</b>
05.A Chassis	FRONT RIGHT SIDE CHASSIS & MIDDLE REPAIRED, INNER DENT	الشاصيه
<b>06 Engine Condition</b>		<b>المحرك</b>
06.A Visual Engine Condition	MINOR OIL LEAK	حالة المحرك النظري
<b>07 Suspension System</b>		<b>ممتص الصدمات</b>
07.A Arms	LOWER ARM BUSH CRACKED	ازرع
