## TEST CERTIFICATE

Site Number	840-Emirates Auctions	Transaction Date	25 Jan 2022, 14:15:22
Transaction Number	32226867 (CC10006)	Queue Number	312309

Chassis Number	5N1AA08B56N728556
Engine Number	
Vehicle Class	Car
Manufacturer	Nissan
Model	Armada
Model Year	2006
Color	White
Mileage	394169 Km
Fuel Type	Petrol
No. Of Cylinders	8
Specification	GCC Specification

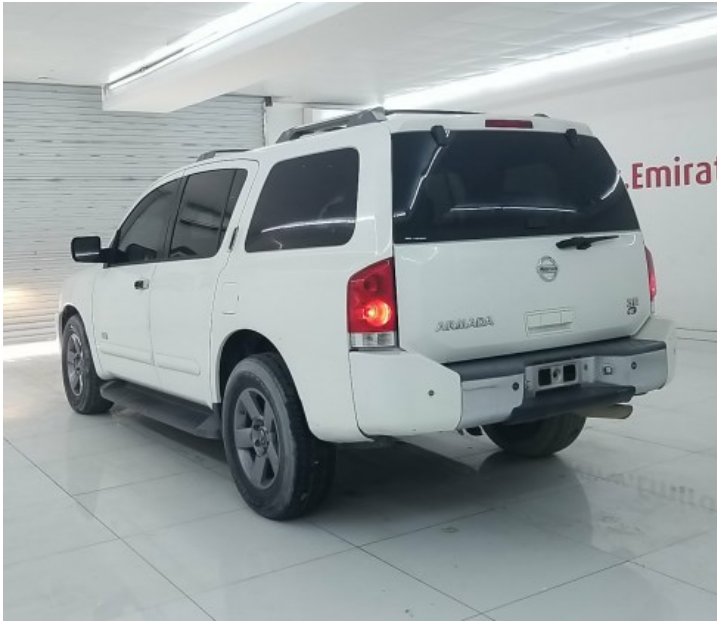
DEFECT	REMARKS	
<b>01 Seats Condition</b>		المقاعد
01.A Seat Condition	SEAT HAVE EXTRA COVER	حالة المقاعد
<b>02 Interior Condition</b>		الحالة الداخليه
02.A Mirror	BOTH SIDE ADJUSTMENT NOT WORKING PROPERLY	المرايا
02.B Dash Board	DASHBOARD&CENTER CONSOLE BOX DAMAGED & HAVE EXTRA SWITCH&ONE SWITCH MISSING	لوحة القيادة
02.C Roof Light	ROOF CONSOLE BOX MISSING	أنارة السقف
02.D Steering Wheel and control buttons	WORN OUT	عجلة القيادة وازرار التحكم
02.E Power Window Switch	FRONT RIGHT SIDE & REAR BOTH SIDE NOT WORKING	مفتاح النافذه
02.F AC Condition	OK&GRILL DAMAGED	المكيف
<b>03 Lights</b>		الاضاءة
03.A Head Light	MINOR FADED	الاضاءة الرئيسية
03.B Fog light	BOTH SIDE LOOSE , LENS BROKEN , NOT WORKING	كشاف الضباب
03.C Brake Light	LEFT SIDE NOT WORKING	نور الفرامل
<b>04 Steering Condition</b>		المقود
04.A Axel	FRONT AXLE BOOT CUT	اكسلات

DEFECT	REMARKS	
04.B Tie Rod End	BOOT CUT	مؤخرة الرودادات
04.C Steering Oil	OIL LEAK&NOISY,WHEEL HARD	زيت المقود
04.D Steering Boot	BOOT CUT	ربلة المقود
<b>05 Engine Condition</b>		<b>المحرك</b>

05.A Visual Engine Condition	OIL LEAK,REFITTED	حالة المحرك النظرى
<b>06 Transmission Condition</b>		<b>الجير</b>
06.A Visual Gear Box Condition	OIL LEAK,REFITTED,JERKING	حالة الجير النظرى

06.B Road Test	NOT CHECK	فحص علي الطريق
06.C DIFFERENTIAL	DIFFERENTIAL MOUNT BUSH CUT	الدفرنشيل
06.D Propeller Shaft	FRONT PROPELLER SHAFT MISSING	ناقل الحركة
<b>07 Tires and Rims Condition</b>		<b>الاطارات</b>

07.A Spare Tire &Tools	SPARE TIRE MISSING	الاطار الاحتياطي و العدة
07.B Front Tyre	BOTH SIDE 2018/2019 CRACKED	الاطار الامامي
07.C Rear Tyre	BOTH SIDE 2019 CRACKED	الاطار الخلفي
<b>08 Suspension System</b>		<b>ممتص الصدمات</b>

08.A Arms	FRONT LOWER ARM BUSH WORN OUT	ازرع
08.B Shock Absorber	FRONT & REAR RIGHT SIDE SHOCK ABSORBER MINOR OIL LEAK	ممتص الصدمات
<b>09 Body</b>		<b>جسم المركبة</b>

09.A Roof	ROOF PORTION RUSTY	السقف
09.B Trunk	NOT OPENING	صندوق
09.C Windshield	FRONT WINDSHIELD CRACKED	زجاج
09.D Paint	BODY TOTALY REPAINTED EXCEPT ROOF,TRUNK & PORTION REPAIRED	الصبغ

09.E Bumper	REPAINTED	دعامية
09.F Door Handle &Lock	FRONT LEFT SIDE OUTER HANDLE &FRONT RIGHT SIDE INNER HANDLE COVER MISSING	مقابض الأبواب والأقفال
<b>10 Brake Condition</b>		<b>الفرامل</b>

10.A Hand Brake	NOT WORKING	فرامل اليد
<b>11 Chassis Condition</b>		<b>الشاسي</b>
11.A Chassis	OK	الشاسيه
