## TEST CERTIFICATE

Site Number	<b>840-Emirates Auctions</b>	Transaction Date	<b>20 Jul 2022, 15:39:51</b>
Transaction Number	<b>60637168 (CC10006)</b>	Queue Number	<b>312309</b>

Chassis Number	<b>1GCRKSE32BZ198062</b>
Engine Number	
Vehicle Class	<b>Heavy</b>
Manufacturer	<b>Chevrolet</b>
Model	<b>Silverado</b>
Model Year	<b>2011</b>
Color	<b>White</b>
Mileage	<b>147715 Miles</b>
Fuel Type	<b>Petrol</b>
No. Of Cylinders	<b>8</b>
Specification	<b>USA Imported</b>

# Test Certificate

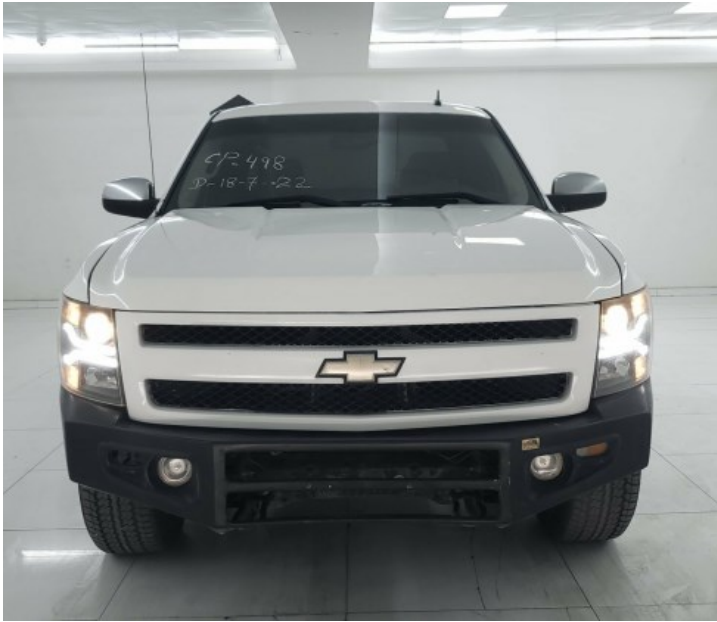
DEFECT	REMARKS	
<b>01 Transmission Condition</b>		<b>الجير</b>
01.A Road Test	NOT CHECK	فحص علي الطريق
01.B Visual Gear Box Condition	REFITTED	حالة الجير النظري
<b>02 Lights</b>		<b>الاضاءة</b>
02.A Warning Light	WARNING LIGHT ON IN DISPLAY	ضوء تحذير
02.B Tail Light	RIGHT SIDE CRACKED	الانارة
<b>03 Interior Condition</b>		<b>الحاله الداخليه</b>
03.A Power Window Switch	REAR RIGHT SIDE NOT WORKING	مفتاح النافذه
03.B AC Condition		المكيف
03.C Dash Board	CRACKED	لوحة القيادة
<b>04 Tires and Rims Condition</b>		<b>الاطارات</b>
04.A Rear Tyre	BOTH SIDE 2021	الاطار الخلفي
04.B Front Tyre	BOTH SIDE 2021	الاطار الامامي
<b>05 Steering Condition</b>		<b>المقود</b>
05.A Axel	LEFT SIDE BOOT CUT	اكسلات

DEFECT	REMARKS	
05.B Steering Oil	SIGN OF LEAK	زيت المقود
05.C Tie Rod End	BOOT CUT	مؤخرة الرودادات
<b>06 Body</b>		<b>جسم المركبة</b>
06.A Sign of front accident		وجود مؤشر لحادث في المقدمة
06.B Other	FRONT FENDER FRAME, RADITOR SUPPORT REPAIRED	اخرى
06.C Bumper	FRONT BUMPER FRAME MISSING	دعامية
06.D Rusty	UNDER BODY PARTS, SUSPENSION ,CHASSIS FRAME GETTING RUSTY	صدأ
06.E Paint	BODY TOTALY REPAINTED & REPAIRED,MINOR DENT,SCRATCHES	الصبغ
<b>07 Engine Condition</b>		<b>المحرك</b>
07.A Visual Engine Condition	REFITTED, MISFIRING	حالة المحرك النظرى
07.B Smoke	WHITE SMOKE	دخان
<b>08 Chassis Condition</b>		<b>الشاسي</b>
08.A Chassis	FRONT BOTH SIDE CHASSIS END DENT & CHASSIS FRAME COMPLETELY PORTION RUST PROOFED, GETTING RUSTY	الشاسيه
