## TEST CERTIFICATE

Site Number	<b>840-Emirates Auctions</b>	Transaction Date	<b>03 Jul 2022, 15:48:05</b>
Transaction Number	<b>38920971 (CC10006)</b>	Queue Number	<b>312309</b>

Chassis Number	<b>JTJHY00W9D4110573</b>
Engine Number	
Vehicle Class	<b>Car</b>
Manufacturer	<b>Lexus</b>
Model	<b>LX 570</b>
Model Year	<b>2013</b>
Color	<b>White</b>
Mileage	<b>158483 Km</b>
Fuel Type	<b>Petrol</b>
No. Of Cylinders	<b>8</b>
Specification	<b>GCC Specification</b>

# Test Certificate

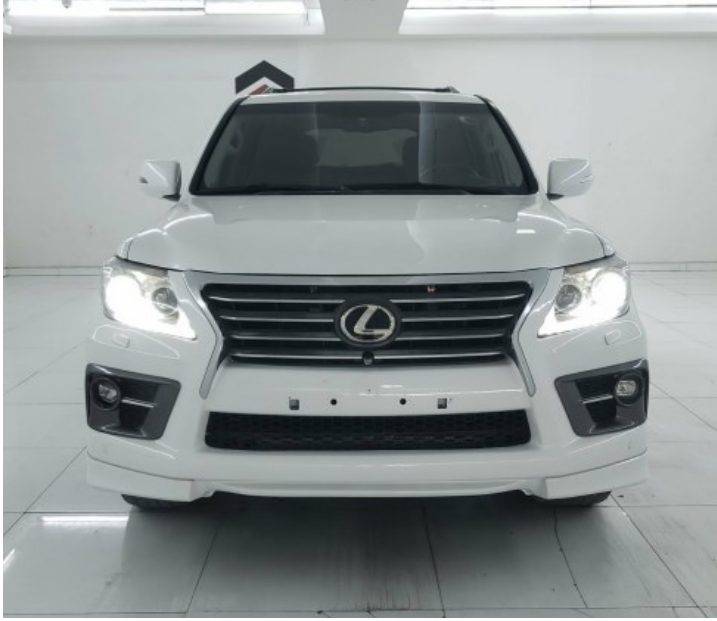
DEFECT	REMARKS	
<b>01 Interior Condition</b>		<b>الحاله الداخليه</b>
01.A AC Condition	OK & GRILL LOOSE	المكيف
01.B Air Bag	LEFT SIDE AIR BAG DAMAGED	وسائد هوائية
<b>02 Body</b>		<b>جسم المركبة</b>
02.A Paint	BODY TOTALY REPAINTED & PORTION REPAIRED,MINOR DENT,SCRATCHES	الصبغ
02.B Bonnet	REFITTED	غطاء المحرك
02.C Pillars	BOTH SIDE A/PILLAR OUTER PANEL REPAIRED,REPAINTED	القوائم
02.D Sign of front accident		وجود مؤشر لحادث في المقدمة
02.E Sign of side accident		وجود مؤشر لحادث في الجانب
02.F Floor	UNDER FLOOR THICK RUST PROOFED & TOO MUDDY	الارضية
02.G Other	FRONT BUMPER FRAME BULK HEAD FENDER REPAIRED	اخرى
02.H Fenders	FRONT FENDER REFITTED	مدكار
02.I Doors	FRONT LEFT SIDE REFITTED	أبواب
<b>03 Transmission Condition</b>		<b>الجير</b>
03.A Road Test	NOT CHECK	فحص علي الطريق
03.B Visual Gear Box Condition	MINOR OIL LEAK	حالة الجير النظري

DEFECT	REMARKS	
03.C DIFFERENTIAL	REAR MINOR OIL LEAK	الدفرنشيل
03.D Gear Box Mount	MOUNT RUBBER CRACKED	كرسي الجير
<b>04 Tires and Rims Condition</b>		<b>الاطارات</b>

04.A Front Tyre	BOTH SIDE 2019 & RIGHT SIDE MINOR WORN OUT	الاطار الامامي
04.B Rear Tyre	BOTH SIDE 2019	الاطار الخلفي
04.C Rims Condition	RIMS HAVE MINOR DENT SCRATCHES	حالة الجنوط
<b>05 Engine Condition</b>		<b>المحرك</b>

05.A Visual Engine Condition	MINOR OIL LEAK	حالة المحرك النظري
05.B Mount	MOUNT RUBBER CRACKED	كرسي
<b>06 Suspension System</b>		<b>ممتص الصدمات</b>
06.A Arms	BOTH SIDE LOWER ARM BUSHES CRACKED	ازرع

06.B Ball Joint	BOOT CUT	مفصل كروي
06.C Other	STABILIZER LINK BOOT CUT	اخرى
<b>07 Chassis Condition</b>		<b>الشاسي</b>
07.A Chassis	FRONT LEFT SIDE RIGHT CHASSIS END REPAIRED , RIGHT SIDE END MOUNT RUSTY WEAK	الشاسيه

07.B Other	CHASSIS FRAME GETTING RUSTY	اخرى
<b>08 Lights</b>		<b>الاضاءة</b>
08.A Warning Light	WARNING LIGHT ON IN DISPLAY	ضوء تحذير
