TEST CERTIFICATE

Chassis Number	1GCNK9E0XDZ108995
Engine Number	
Vehicle Class	Car
Manufacturer	Chevrolet
Model	
Model Year	2013
Color	Red
Mileage	94719

Test Certificate

Certificate Number :	5-TAS-2021-15057183
Inspection Date :	20-09-2021
Certificate Print Date :	20-09-2021
Services :	Registration Test
Vehicle Testing Partner :	Tasjeel
Vehicle Testing Center :	Tasjeel Al Aweer
Total Time Taken :	21 min 30 sec
Appointment Ref Number :	--
Start Time :	13:45
End Time :	14:06
Lane :	01
Token No. :	159
Attempt :	1
Prints No :	1

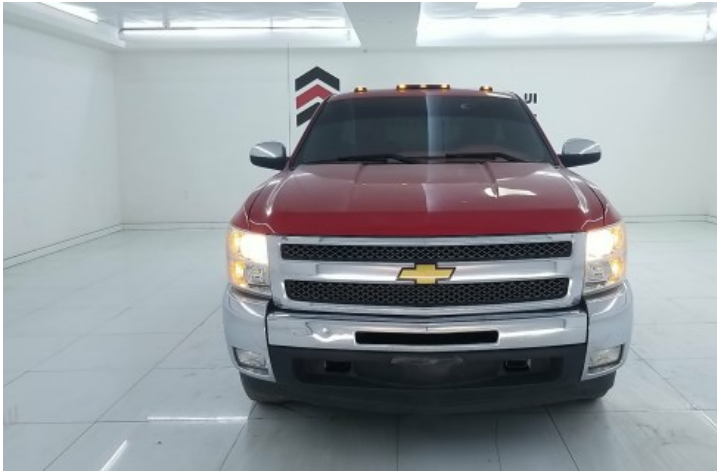
DEFECT	REMARKS	
01 Body		جسم المركبة
01.A Fenders	PORTION REPAIRED & REPAINTED	مدكار
01.B Paint	PORTION REPAIRED, REPAINTED & DENTS, SCRATCHES ON BODY	الصبغ
01.C Rusty	UNDER BODY PARTS, CHASSIS FRAME GETTING RUSTY	صدأ
01.D Floor	UNDER FLOOR COMPLETELY RUST PROOFED	الارضية
01.E Bumper	REPAINTED	دعامية
01.F Bonnet	PORTION REPAIRED, REPAINTED	غطاء المحرك
01.G Other	FRONT FENDER FRAME, BUMPER FRAME , RADITOR SUPPORT , BULK HEAD & CROSSMEMBER REPAIRED OLD GETTING RUSTY	اخرى
02 Chassis Condition		الشاصي
02.A Chassis	CHASSIS FRAME COMPLETELY RUST PROOFED & FRONT BOTH SIDE END REPAIRED, RIGHT SIDE OUTER MIDDLE SLIGHTLY BEND	الشاسيه
03 Engine Condition		المحرك
03.A Mount	BUSHES CRACKED	كرسي
03.B Other	OK	اخرى
04 Seats Condition		المقاعد
04.A Other	OK	اخرى
05 Exhaust System		نظام العادم

DEFECT	REMARKS	
05.A Other	WELDED & REPAIRED	اخرى
06 Transmission Condition		الجير
06.A Gear Box	OK	الجير
07 Brake Condition		الفرامل
07.A Caliber Brake	GETTING RUSTY	جهاز الفرامل
08 Wipers and Arms		المساحات
08.A Other	OK	اخرى
09 Lights		الاضاءة
09.A Head Light	OK	الاضاءة الرئيسية
09.B Other	OK	اخرى
10 Suspension System		ممتص الصدمات
10.A Arms	FRONT BOTH SIDE LOWER ARMS & REAR CONTROL ARMS BUSHES CRACKED	ازرع
10.B Leaf Spring	BOTH SIDE BUSHES CRACKED & LEAF GETTING RUSTY	
11 Tires and Rims Condition		الاطارات
11.A Front Tyre	BOTH SIDE 2019	الاطار الامامي
11.B Rear Tyre	BOTH SIDE 2019	الاطار الخلفي
12 Interior Condition		الاجزاء الداخلية
12.A Other	OK	اخرى
12.B Mirror	OK	المرآيا
12.C AC Condition	OK	المكيف
13 Steering Condition		المقود
13.A Steering Boot	BOOT CUT & LEAKING	ربلة المقود
