## TEST CERTIFICATE

Chassis Number	<b>MROFX22G291316410</b>
Engine Number	
Vehicle Class	<b>Heavy</b>
Manufacturer	<b>Toyota</b>
Model	<b>Hilux</b>
Model Year	<b>2009</b>
Color	<b>White</b>
Mileage	<b>966861 Km</b>
Fuel Type	<b>Petrol</b>
No. Of Cylinders	<b>4</b>
Specification	<b>GCC Specification</b>

# Test Certificate

Certificate Number :	5-TAS-2022-15857635
Inspection Date :	10-01-2022
Certificate Print Date :	10-01-2022
Services :	Registration Test
Vehicle Testing Partner :	Tasjeel
Vehicle Testing Center :	Tasjeel Al Aweer
Total Time Taken :	13 min 46 sec
Appointment Ref Number :	--
Start Time :	13:21
End Time :	13:34
Lane :	03
Token No. :	182
Attempt :	1
Prints No :	1

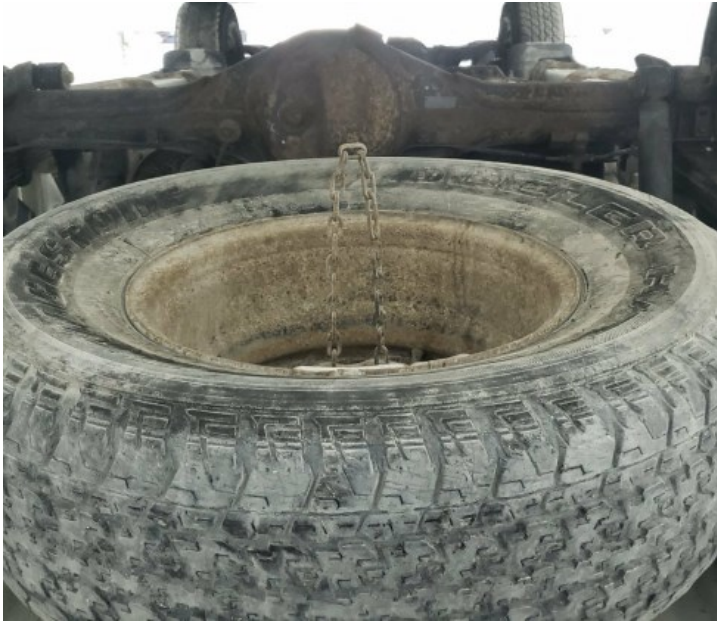
DEFECT	REMARKS	
<b>01 Body</b>		<b>جسم المركبة</b>
01.A Doors	LEFT SIDE BOTH REPAIRED & REPAINTED	أبواب
01.B Floor	REAR CARRIOR BOX PORTION REPAIRED & REPAINTED	الارضية
01.C Paint	PORTION REPAIRED, REPAINTED & DENTS, SCRATCHES ON BODY	الصبغ
01.D Rusty	UNDER BODY PARTS, SUSPENSION , CHASSIS , FLOOR GETTING RUSTY	صدأ
<b>02 Lights</b>		<b>الاضاءة</b>
02.A Warning Light	WARNING LIGHT ON IN DISPLAY	ضوء تحذير
02.B Head Light	OK	الاضاءة الرئيسية
02.C Brake Light	RIGHT SIDE NOT WORKING	نور الفرامل
<b>03 Wipers and Arms</b>		<b>المساحات</b>
03.A Wiper Arm &Blade	WORN OUT	ازرع المساحات والشفرات
<b>04 Interior Condition</b>		<b>الحاله الداخليه</b>
04.A AC Condition	OK	المكيف
04.B Mirror	OK	المرايا
04.C Dash Board	INNER BOX COVER HOLDER LOCK DAMAGED	لوحة القيادة

DEFECT	REMARKS	
<b>05 Tires and Rims Condition</b>		الاطارات
05.A Front Tyre	BOTH SIDE 2021	الاطار الامامي
05.B Rear Tyre	BOTH SIDE 2021	الاطار الخلفي
<b>06 Chassis Condition</b>		الشاصي
06.A Chassis	CHASSIS FRAME COMPLETELY RUSTY	الشاسيه
<b>07 Suspension System</b>		ممتص الصدمات
07.A Arms	FRONT BOTH SIDE LOWER ARMS & REAR CONTROL ARMS BUSHES CRACKED	ازرع
07.B Leaf Spring	BOTH SIDE BUSHES CRACKED & LEAF GETTING RUSTY	
<b>08 Steering Condition</b>		المقود
08.A Steering Boot	BOOT CUT & LEAKING	ربلة المقود
08.B Steering Oil	OIL LEAK	زيت المقود
