## TEST CERTIFICATE

Site Number **840-Emirates Auctions** Transaction Date **14 Nov 2022, 11:33:50**  
 Transaction Number **75275217 (CC10009)** Queue Number **622005**

Chassis Number **2T2ZK1BA3FC165175**  
 Engine Number  
 Vehicle Class **Car**  
 Manufacturer **Lexus**  
 Model **RX 350**  
 Model Year **2015**  
 Color **Gold**  
 Mileage **70785 Miles**  
 Fuel Type **Petrol**  
 No. Of Cylinders **6**  
 Specification **Imported**

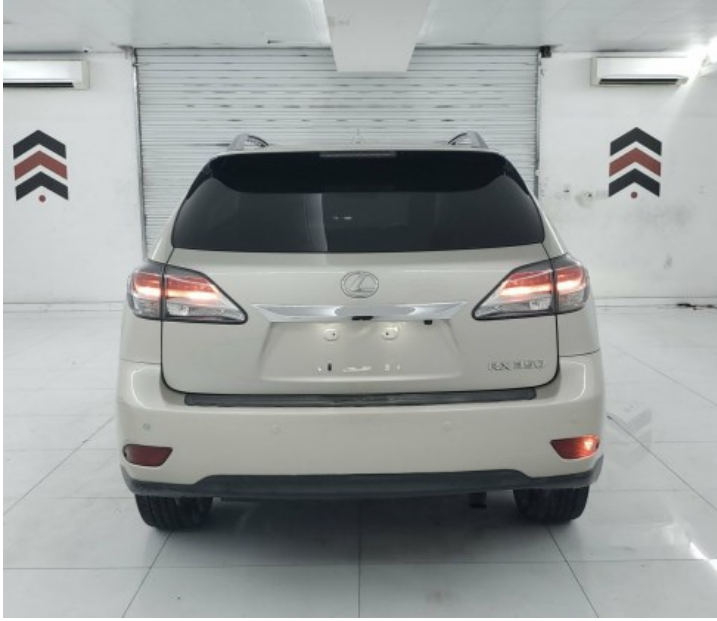
DEFECT	REMARKS	
<b>01 Suspension System</b>		<b>ممتص الصدمات</b>
01.A Ball Joint	BOOT CUT	مفصل كروي
01.B Arms	LOWER ARM BUSHES CRACKED	ازرع
<b>02 Body</b>		<b>جسم المركبة</b>
02.A Other	LEFT SIDE ROOF RAIL REPAINTED	اخرى
02.B Sign of side accident		وجود مؤشر لحادث في الجانب
02.C Sign of front accident		وجود مؤشر لحادث في المقدمة
02.D Fenders	FRONT BOTH SIDE , REAR LEFT SIDE REPAIRED REPAINTED , FRONT REFITTED	مدكار
02.E Doors	LEFT SIDE BOTH REPAIRED REPAINTED & REFITTED	أبواب
02.F Paint	BODY PORTION REPAIRED , REPAINTED & MINOR DENT ,SCRATCHES,	الصبغ
02.G Pillars	LEFT SIDE A/ PILLAR REPAIRED	القوائم
02.H Bonnet	PORTION REPAIRED REPAINTED & REFITTED	غطاء المحرك
02.I Floor	FLOOR PORTION LEFT SIDE REINFORCMENT ROCKER PANEL REPAIRED	الارضية
<b>03 Interior Condition</b>		<b>الحالة الداخليه</b>
03.A AC Condition	OK	المكيف

DEFECT	REMARKS	
<b>04 Engine Condition</b>		<b>المحرك</b>
04.A Mount	MOUNT RUBBER CRACKED	كرسي
04.B Visual Engine Condition	MINOR OIL LEAK	حالة المحرك النظري
<b>05 Transmission Condition</b>		<b>الجير</b>
05.A Visual Gear Box Condition	JERKING	حالة الجير النظري
05.B Gear Box Mount	MOUNT CRACK	كرسي الجير
05.C Road Test	NOT CHECK	فحص علي الطريق
<b>06 Steering Condition</b>		<b>المقود</b>
06.A Tie Rod End	BOOT CUT	مؤخرة الرودادات
<b>07 Lights</b>		<b>الاضاءة</b>
07.A Tail Light	RIGHT SIDE CRACKED	الانارة
<b>08 Tires and Rims Condition</b>		<b>الاطارات</b>
08.A Front Tyre	BOTH SIDE 2018 CRACKED,	الاطار الامامي
08.B Rear Tyre	BOTH SIDE 2018 CRACKED,	الاطار الخلفي
<b>09 Chassis Condition</b>		<b>الشاصي</b>
09.A Chassis	FRONT LEFT SIDE CHASSIS JOINT AREA REPAIRED	الشاسيه
