## TEST CERTIFICATE

Site Number	<b>840-Emirates Auctions</b>	Transaction Date	<b>08 May 2022, 17:24:17</b>
Transaction Number	<b>49824718 (CC10006)</b>	Queue Number	<b>312309</b>

Chassis Number	<b>5FNYP48469B701494</b>
Engine Number	
Vehicle Class	<b>Car</b>
Manufacturer	<b>Honda</b>
Model	<b>Pilot</b>
Model Year	<b>2009</b>
Color	<b>Beige</b>
Mileage	<b>421483 Km</b>
Fuel Type	<b>Petrol</b>
No. Of Cylinders	<b>6</b>
Specification	<b>GCC Specification</b>

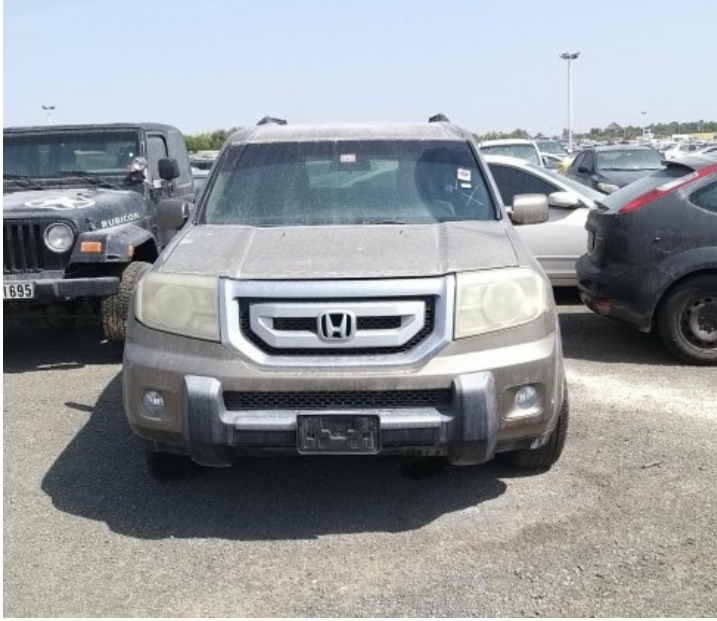
DEFECT	REMARKS	
<b>01 Suspension System</b>		<b>ممتص الصدمات</b>
01.A Other	STABILIZER LINK BOOT CUT	اخرى
01.B Arms	REAR CONTROL ARM BUSH CUT	ازرع
01.C Ball Joint	BOOT CUT	مفصل كروي
<b>02 Transmission Condition</b>		<b>الجير</b>
02.A Visual Gear Box Condition	OK	حالة الجير النظرى
02.B Propeller Shaft	RUBBER CUT	ناقل الحركة
02.C Road Test	NOT CHECK	فحص علي الطريق
02.D Gear Box Mount	MOUNT BUSH CRACKED	كرسي الجير
<b>03 Tires and Rims Condition</b>		<b>الاطارات</b>
03.A Rear Tyre	BOTH SIDE 2019 BADLY CRACKED , WORN OUT	الاطار الخلفي
03.B Front Tyre	BOTH SIDE 2020 CRACKED , WORN OUT	الاطار الامامي
03.C Spare Tire &Tools	SPARE TIRE MISSING	الاطار الاحتياطي و العدة
03.D Rims Condition	RIMS HAVE MINOR DENT SCRATCHES	حالة الجنوط
<b>04 Steering Condition</b>		<b>المقود</b>
04.A Steering Oil	OIL LEAK	زيت المقود

DEFECT	REMARKS	
04.B Tie Rod End	BOOT CUT	مؤخرة الرودادات
04.C Axle	BOOT CUT	اكسلات
<b>05 Lights</b>		<b>الاضاءة</b>
05.A Head Light	LENS FADED	الاضاءة الرئيسية
<b>06 Interior Condition</b>		<b>الحالة الداخليه</b>

06.A AC Condition	NOT COOLING	المكيف
<b>07 Body</b>		<b>جسم المركبة</b>
07.A Fenders	FRONT BOTH SIDE REPAIRED,REPAINTED & REFITTED & REAR RIGHT SIDE PORTION REPAIRED,REPAINTED	مذكار

07.B Paint	BODY PORTION REPAIRED,REPAINTED & MINOR DENT SCRATCHES & PORTION FADED, RUSTY	الصبغ
07.C Doors	FRONT BOTH SIDE REPAINTED,PORTION REPAIRED	أبواب

07.D Trunk	PORTION REPAINTED	صندوق
07.E Bumper	MISALIGN	دعامية
07.F Other	FRONT FENDER FRAME, RADITOR SUPPORT REPAIRED	اخرى
<b>08 Engine Condition</b>		<b>المحرك</b>

08.A Visual Engine Condition	OIL LEAK	حالة المحرك النظرى
<b>09 Chassis Condition</b>		<b>الشاسي</b>
09.A Chassis	OK	الشاسيه
<b>10 Seats Condition</b>		<b>المقاعد</b>

10.A Seat Condition	SEATS HAVE EXTRA COVER	حالة المقاعد
