TEST CERTIFICATE

Site Number	840-Emirates Auctions	Transaction Date	21 Apr 2022, 14:19:57
Transaction Number	45102989 (CC10008)	Queue Number	312309

Chassis Number	2G1175S34E9150235
Engine Number	
Vehicle Class	Car
Manufacturer	Chevrolet
Model	Impala
Model Year	2014
Color	White
Mileage	001 Km
Fuel Type	Petrol
No. Of Cylinders	6
Specification	GCC Specification

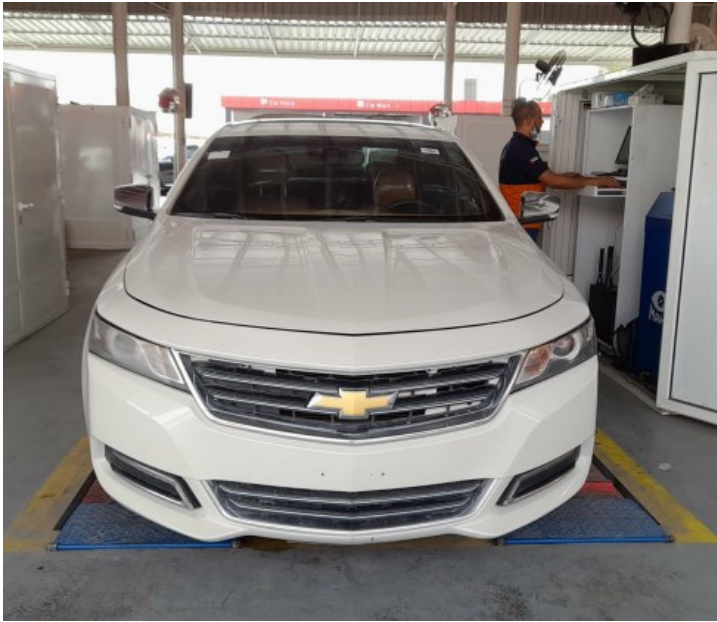
DEFECT	REMARKS	
01 Body		جسم المركبة
01.A Paint	BODY REPAINTED,REPAIRED,MINOR DENT,SCRATCHES	الصبغ
01.B Other	FRONT FENDER FRAME,APRON WHEEL HOUSING ,BULK HEAD,BUMPER FRAME RADIATOR SUPPORT REPAIRED	اخرى
01.C Floor	FRONT LEFT SIDE RUNNING BOARD REPAIRED	الارضية
01.D Pillars	FRONT SIED A/PILLAR&LEFT SIDE B/PILLAR ,ROCKER ROCKER PANEL REPAIRED	القوائم
01.E Sign of side accident		وجود مؤشر لحادث في الجانب
01.F Sign of front accident		وجود مؤشر لحادث في المقدمة
01.G Doors	FRONT LEFT SIDE DOOR HING HOLDER MISSING	أبواب
02 Interior Condition		الحالة الداخلية
02.A Odometer reading	ODOMETER NOT SHOWING	قراءة عداد المسافات
02.B AC Condition	OK	المكيف
02.C Door Panel	FRONT LEFT SIDE DAMAGED	لوحة بطانة الباب
02.D Power Window Switch	MAIN SWITCH LOOSE	مفتاح النافذة
02.E Steering Wheel and control buttons	AIR BAG UNIT DAMAGED&CONTROL BUTTON NOT WORKING	عجلة القيادة وازرار التحكم
03 Lights		الاضاءة

DEFECT	REMARKS	
03.A Warning Light	WARNING LIGHT ON IN DISPLAY	ضوء تحذير
04 Tires and Rims Condition		الاطارات
04.A Front Tyre	BOTH SIDE 2021 WORNOUT	الاطار الامامي
04.B Rear Tyre	BOTH SIDE 2021	الاطار الخلفي
04.C Rims Condition	FRONT RIGHT SIDE WELDED REPAIRED	حالة الجنوط
05 Chassis Condition		الشاصي
05.A Chassis	FRONT LEFT SIDE CHASSIS END REPAIRED,CHASSIS MINOR BEND	الشاسيه
06 Engine Condition		المحرك
06.A Visual Engine Condition	OIL LEAK	حالة المحرك النظري
07 Transmission Condition		الجير
07.A Visual Gear Box Condition	OK	حالة الجير النظري
07.B Road Test	NOT CHECK	فحص علي الطريق
08 Battery Condition		حالة البطارية
08.A Battery bracket	VEHICLE COMPUTER FIXED BY WIRE	حامل البطارية
