## TEST CERTIFICATE

Site Number	<b>840-Emirates Auctions</b>	Transaction Date	<b>10 Aug 2022, 13:16:33</b>
Transaction Number	<b>49547885 (CC10006)</b>	Queue Number	<b>312309</b>

Chassis Number	<b>JTDEPRAE9LJ007396</b>
Engine Number	
Vehicle Class	<b>Car</b>
Manufacturer	<b>Toyota</b>
Model	<b>Corolla</b>
Model Year	<b>2020</b>
Color	<b>Silver</b>
Mileage	<b>44373 Miles</b>
Fuel Type	<b>Petrol</b>
No. Of Cylinders	<b>4</b>
Specification	<b>USA Imported</b>

# Test Certificate

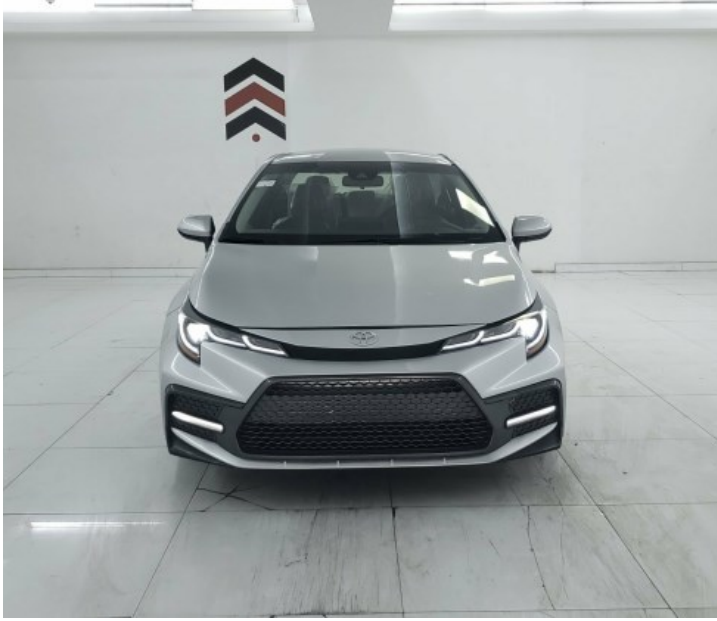
DEFECT	REMARKS	
<b>01 Interior Condition</b>		<b>الحاله الداخليه</b>
01.A Air Bag	DAMAGED	وسائد هوائية
01.B AC Condition	OK	المكيف
01.C Sun Visor	RIGHT SIDE LOOSE	حاجب الشمس
<b>02 Tires and Rims Condition</b>		<b>الاطارات</b>
02.A Front Tyre	BOTH SIDE 2020	الاطار الامامي
02.B Rear Tyre	BOTH SIDE 2020	الاطار الخلفي
<b>03 Body</b>		<b>جسم المركبة</b>
03.A Pillars	PILLAR OUTER PANEL ,LEFT QUARTER PANEL REPAIRED,REPAINTED	القوائم
03.B Sign of side accident		وجود مؤشر لحادث في الجانب
03.C Paint	BODY TOTALY REPAINTED REPAIRED,MINOR DENT,SCRATCHES	الصبغ
03.D Sign of front accident		وجود مؤشر لحادث في المقدمة
03.E Fenders	FRONT BOTH SIDE REFITTED	مدكار
03.F Bonnet	REFITTED	غطاء المحرك
03.G Bumper	MISALIGN.FRONT BUMPER FRAME ,FENDER FRAME ,BULKHEAD RPAIRED	دعامية

DEFECT	REMARKS	
03.H Doors	FRONT RIGHT SIDE DOOR REPLACED.	أبواب
03.I Rusty	UNDER BODY PARTS ,SUSPENSION GETTING RUSTY.	صدأ
<b>04 Transmission Condition</b>		<b>الجير</b>
04.A Visual Gear Box Condition	OIL LEAK	حالة الجير النظرى
04.B Road Test	NOT CHECK	فحص علي الطريق
<b>05 Engine Condition</b>		<b>المحرك</b>
05.A Visual Engine Condition	OIL LEAK,	حالة المحرك النظرى
<b>06 Suspension System</b>		<b>ممتص الصدمات</b>
06.A Arms	FRONT SUSPENSION REFITTED.	ازرع
<b>07 Chassis Condition</b>		<b>الشاسي</b>
07.A Chassis	FRONT LEFT SIDE CHASSIS BEND .	الشاسيه
