TEST CERTIFICATE

Site Number	840-Emirates Auctions	Transaction Date	09 Sep 2021, 10:41:09
Transaction Number	21714015 (CC10006)	Queue Number	312309

Chassis Number	3GKFK16R3VG523567
Engine Number	
Vehicle Class	Car
Manufacturer	GMC
Model	Suburban
Model Year	1997
Color	White
Mileage	271034

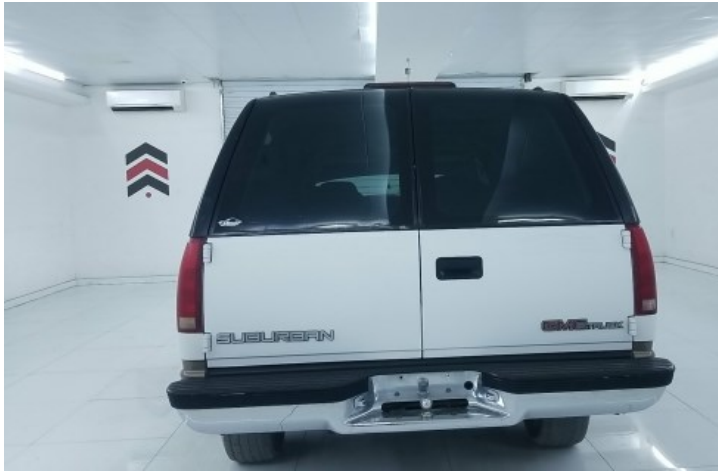
DEFECT	REMARKS	
01 Body		جسم المركبة
01.A Fenders	PORTION REPAIRED & REPAINTED	مدكار
01.B Paint	BODY TOTALY PORTION REPAIRED , REPAINTED & DENTS ,SCRATCHES ON BODY	الصبغ
01.C Doors	PORTION REPAIRED & REPAINTED	أبواب
01.D Rusty	UNDER BODY PARTS, FLOORING, CHASSIS GETTING RUSTY	صدأ
01.E Bumper	REPAINTED	دعامية
01.F Bonnet	PORTION REPAIRED & REPAINTED	غطاء المحرك
01.G Other	FRONT FENDER FRAME, BUMPER FRAME , RADITOR SUPPORT , BULK HEAD & CROSSMEMBER REPAIRED OLD	اخرى
02 Chassis Condition		الشاصي
02.A Chassis	CHASSIS FRAME COMPLETLY RUSTY & MIDDLE SLIGHTLY BEND	الشاسيه
03 Engine Condition		المحرك
03.A Mount	BUSHES CRACKED	كرسي
04 Seats Condition		المقاعد
04.A Other	OK	اخرى
05 Exhaust System		نظام العادم
05.A Other	WELDED & REPAIRED	اخرى
06 Transmission Condition		الجير

DEFECT	REMARKS	
06.A Gear Box	MINOR LEAK	الجير
07 Tires and Rims Condition		الاطارات
07.A Front Tyre	BOTH SIDE 2018 CRACKED	الاطار الامامي
07.B Rear Tyre	BOTH SIDE 2018 CRACKED	الاطار الخلفي
08 Wipers and Arms		المساحات

08.A Other	WORN OUT	اخرى
09 Lights		الاضاءة
09.A Head Light	OK	الاضاءة الرئيسية
09.B Other	OK	اخرى
10 Brake Condition		الفرامل
10.A Caliber Brake	GETTING RUSTY	جهاز الفرامل
11 Suspension System		ممتص الصدمات

11.A Arms	FRONT BOTH SIDE LOWER ARMS & REAR CONTROL ARMS BUSHES CRACKED	ازرع
11.B Leaf Spring	BOTH SIDE BUSHES CRACKED & LEAF GETTING RUSTY	
12 Steering Condition		المقود

12.A Steering Box	OIL LEAK	جهاز المقود
12.B Tie Rod End	BUSHES CUT	مؤخرة الرودادات
12.C Other	STABILIZER LINK & CONTROL BAR BUSHES DRY CRACKED	اخرى
13 Interior Condition		الاجزاء الداخلية

13.A Other	BOTH SIDE SEAT BELT NOT WORKING	اخرى
13.B AC Condition	OK	المكيف
13.C Mirror	RIGHT SIDE STAND MIRROR REPAIRED	المرابا
