TEST CERTIFICATE

Site Number	840-Emirates Auctions	Transaction Date	23 Jan 2023, 14:26:27
Transaction Number	73091866 (CC10010)	Queue Number	657857

Chassis Number	WVWZZZ9CZ2M616787
Engine Number	
Vehicle Class	Car
Manufacturer	Volkswagen
Model	Beetle
Model Year	2002
Color	Yellow
Mileage	216240 Km
Fuel Type	Petrol
No. Of Cylinders	4
Specification	GCC Specification

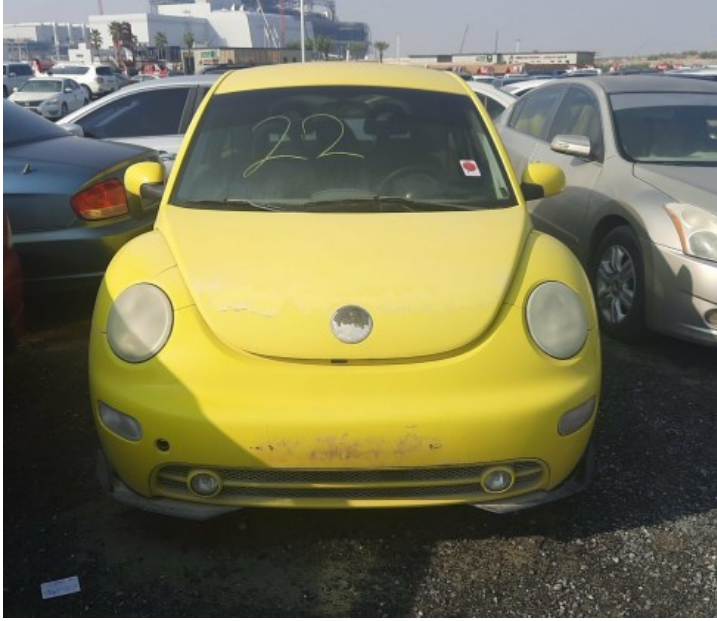
DEFECT	REMARKS	
01 Interior Condition		الحاله الداخليه
01.A Door Panel	PORTION DAMAGED	لوحة بطانة الباب
01.B AC Condition	LOW COOLING	المكيف
01.C Roof Light	SUNGLASS CONSOLE BOX DAMAGED	أنارة السقف
01.D Steering Wheel and control buttons	WORN OUT,HORN NOT WORK.	عجلة القيادة وازرار التحكم
01.E Other	CENTER CONSOLE BOX DAMAGED,GEAR LIVER DUST COVER MISSING .	اخرى
01.F Roof Ceiling	PORTION LOOSE	بطانه السقف
01.G Dash Board	PORTION DAMAGED,GLOVE BOX MISSING	لوحة القيادة
02 Seats Condition		المقاعد
02.A Seat Condition	PORTION DAMAGED	حالة المقاعد
03 Tires and Rims Condition		الاطارات
03.A Front Tyre	BOTH SIDE 2019 CRACKED, WORN OUT	الاطار الامامي
03.B Rear Tyre	BOTH SIDE 2019 CRACKED,	الاطار الخلفي
04 Lights		الاضاءة
04.A Warning Light	WARNING LIGHTS ON DISPLAY.	ضوء تحذير

DEFECT	REMARKS	
04.B Brake Light	RIGHT SIDE NOT WORKING.	نور الفرامل
04.C Head Light	LENS FADED	الاضاءة الرئيسية
05 Body		جسم المركبة
05.A Paint	BODY PORTION REPAIRED , REPAINTED & MINOR DENT ,SCRATCHES,PORTION FADED,	الصبغ

05.B Other	LEFT SIDE QUATER PANEL DAMAGED	اخرى
05.C Fenders	FIBER PAINT CANNOT CHECK & FRONT RIGHT SIDE PORTION DAMAGED	مدكار
05.D Bonnet	SHOCK WEAK,REFITTED,LOCK HANDLE DAMAGED	غطاء المحرك

05.E Rusty	UNDER BODY PARTS SUSPENSION RUSTY	صدأ
05.F Sign of side accident		وجود مؤشر لحادث في الجانب
05.G Floor	UNDER FLOOR,RUNNING BOARD DENT	الارضية
06 Engine Condition		المحرك

06.A Visual Engine Condition	OPEN,REFITTED,OIL LEAK,ABNORMAL NOISY	حالة المحرك النظرى
06.B Smoke	WHITE SMOKE .	دخان
07 Transmission Condition		الجير
07.A Visual Gear Box Condition	REFITTED,OIL LEAK,JERKING.	حالة الجير النظرى

07.B Road Test	NOT CHECK	فحص على الطريق
08 Exhaust System		نظام العادم
08.A Other	EXHAUST CUT & REWELDED	اخرى
09 Suspension System		ممتص الصدمات
09.A Ball Joint	BOOT CUT	مفصل كروي

09.B Arms	LOWER ARM BUSH CUT	ازرع
09.C Shock Absorber	LEAK	ممتص الصدمات
10 Steering Condition		المقود
10.A Steering Oil	OIL LEAK	زيت المقود
10.B Steering Boot	BOOT CUT	ربلة المقود

10.C Axle	BOOT CUT	اكسلات
10.D Tie Rod End	BOOT CUT	مؤخرة الرودادات
11 Chassis Condition		الشاسي
11.A Chassis	CHECKED VISIBLE AREA OK	الشاسيه
