## TEST CERTIFICATE

Chassis Number	<b>JTHBH965565026778</b>
Engine Number	
Vehicle Class	<b>Car</b>
Manufacturer	<b>Lexus</b>
Model	<b>GS 300</b>
Model Year	<b>2006</b>
Color	<b>White</b>
Mileage	<b>215830 Miles</b>
Fuel Type	<b>Petrol</b>
No. Of Cylinders	<b>6</b>
Specification	<b>USA Imported</b>

# Test Certificate

Certificate Number :	5-TAS-2022-16709723
Inspection Date :	08-05-2022
Certificate Print Date :	08-05-2022
Services :	Registration Test
Vehicle Testing Partner :	Tasjeel
Vehicle Testing Center :	Tasjeel Al Aweer
Total Time Taken :	5 min 38 sec
Appointment Ref Number :	--
Start Time :	13:36
End Time :	13:42
Lane :	02
Token No. :	247
Attempt :	1
Prints No :	1

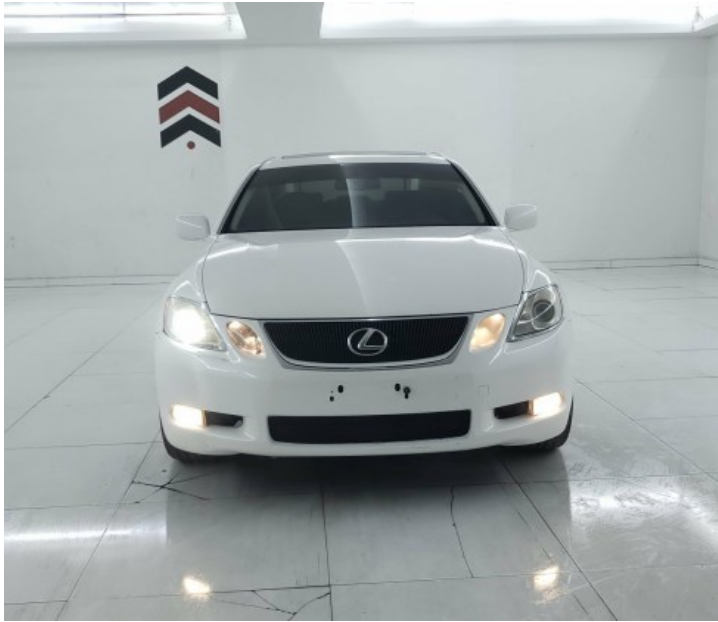
DEFECT	REMARKS	
<b>01 Tires and Rims Condition</b>		<b>الاطارات</b>
01.A Front Tyre	LEFT SIDE 2019 CRACKED & RIGHT SIDE 2021	الاطار الامامي
01.B Rear Tyre	BOTH SIDE 2018 & CRACKED	الاطار الخلفي
<b>02 Chassis Condition</b>		<b>الشاسيه</b>
02.A Chassis	REAR RIGHT SIDE CHASSIS & CHASSIS EXTENSION REPAIRED	الشاسيه
<b>03 Engine Condition</b>		<b>المحرك</b>
03.A Visual Engine Condition	MINOR OIL LEAK ,SHAKING	حالة المحرك النظري
03.B Smoke	WHITE SMOKE	دخان
<b>04 Transmission Condition</b>		<b>الجير</b>
04.A Visual Gear Box Condition	MINOR OIL LEAK	حالة الجير النظري
04.B Road Test	NOT CHECK	فحص علي الطريق
04.C DIFFERENTIAL	REAR DIFFERENTIAL SIGN OF OIL LEAK	الدفرنشيل
<b>05 Body</b>		<b>جسم المركبة</b>
05.A Fenders	FRONT BOTH SIDE & REAR RIGHT SIDE REPAINTED, PORTION REPAIRED	مدكار

DEFECT	REMARKS	
05.B Trunk	REPAINTED,PORTION REPAIRED,REFITTED	صندوق
05.C Bonnet	SHOCK WEAK	غطاء المحرك
05.D Doors	FRONT LEFT SIDE &RIGHT SIDE BOTH DOOR REPAINTED,PORTION REPAIRED	أبواب
05.E Paint	BODY PORTION REPAINTED,PORTION REPAIRED,MINOR DENT,SCRATCHES	الصبغ
05.F Floor	BACK PANEL ,COMPARTMENT ,QUATER PANEL REPAIRED	الارضية
<b>06 Lights</b>		<b>الاضاءة</b>
06.A Warning Light	WARNING LIGHT ON IN DISPLAY	ضوء تحذير
06.B Head Light	LEFT SIDE LOW BEAM NOT WORKING	الاضاءة الرئيسية
<b>07 Interior Condition</b>		<b>الحالة الداخليه</b>
07.A AC Condition	OK	المكيف
07.B Power Window Switch	NOT WORKING FROM MAIN SWITCH	مفتاح النافذه
<b>08 Battery Condition</b>		<b>حالة البطارية</b>
08.A Battery bracket	MISSING	حامل البطارية
