## TEST CERTIFICATE

Site Number	<b>840-Emirates Auctions</b>	Transaction Date	<b>03 Jul 2022, 15:46:45</b>
Transaction Number	<b>77107719 (CC10006)</b>	Queue Number	<b>312309</b>

Chassis Number	<b>JMYMYV87WFJ719819</b>
Engine Number	
Vehicle Class	<b>Car</b>
Manufacturer	<b>Mitsubishi</b>
Model	<b>Pajero</b>
Model Year	<b>2015</b>
Color	<b>Brown</b>
Mileage	<b>115487 Km</b>
Fuel Type	<b>Petrol</b>
No. Of Cylinders	<b>6</b>
Specification	<b>GCC Specification</b>

# Test Certificate

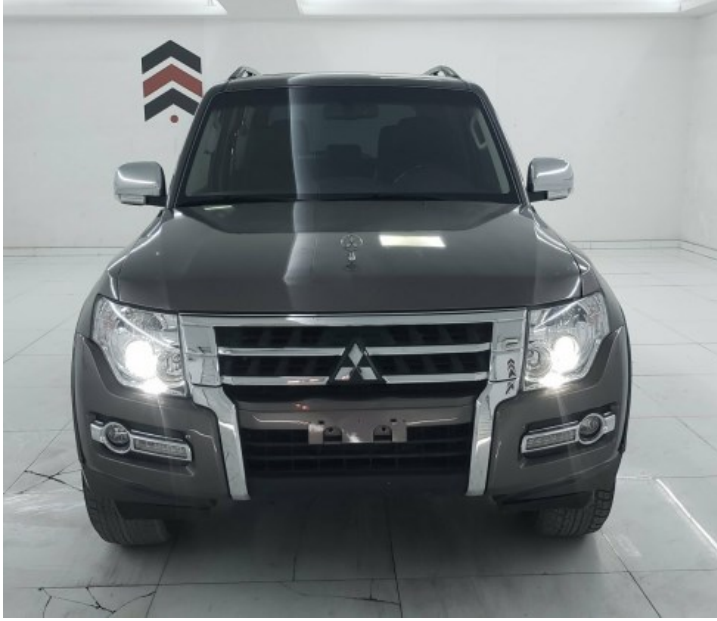
DEFECT	REMARKS	
<b>01 Transmission Condition</b>		<b>الجير</b>
01.A Road Test	NOT CHECK	فحص علي الطريق
01.B Gear Box Mount	MOUNT BUSH CRACKED	كرسي الجير
01.C Visual Gear Box Condition	MINOR OIL LEAK	حالة الجير النظري
<b>02 Tires and Rims Condition</b>		<b>الاطارات</b>
02.A Front Tyre	BOTH SIDE 2020	الاطار الامامي
02.B Rear Tyre	BOTH SIDE 2020	الاطار الخلفي
<b>03 Suspension System</b>		<b>ممتص الصدمات</b>
03.A Shock Absorber	FRONT SHOCK ABSORBER LEAK	ممتص الصدمات
03.B Ball Joint	BOOT CUT	مفصل كروي
03.C Arms	FRONT LOWER ARM BUSH CRACKED	ازرع
<b>04 Interior Condition</b>		<b>الحاله الداخليه</b>
04.A AC Condition	OK & GRILL LOOSE	المكيف
04.B Mirror	LEFT SIDE FOLDING NOT WORKING & ADJUSTMENT NOT WORKING PROPERLY	المرايا
<b>05 Body</b>		<b>جسم المركبة</b>

DEFECT	REMARKS	
05.A Paint	REPAINTED,PORZION REPAIRED,BODY MINOR DENT,SCRATCHES	الصبغ
05.B Fenders	FRONT FENDER REFITTED	مدكار
05.C Bonnet	REFITTED	غطاء المحرك
05.D Sign of front accident		وجود مؤشر لحادث في المقدمة
05.E Other	FRONT FENDER FRAME ,BULK HEAD,BUMPER FRAME RADIATOR SUPPORT REPAIRED	اخرى
<b>06 Lights</b>		<b>الاضاءة</b>
06.A Fog light	NOT WORKING	كشاف الضباب
<b>07 Engine Condition</b>		<b>المحرك</b>
07.A Mount	MOUNT BUSH CRACKED	كرسي
07.B Visual Engine Condition	SIGN OF MINOR OIL LEAK , REFITTED	حالة المحرك النظرى
<b>08 Steering Condition</b>		<b>المقود</b>
08.A Tie Rod End	BOOT CUT	مؤخرة الرودادات
<b>09 Chassis Condition</b>		<b>الشاسي</b>
09.A Chassis	FRONT LEFT SIDE CHASSIS REPAIRED	الشاسيه
