## TEST CERTIFICATE

Site Number	<b>840-Emirates Auctions</b>	Transaction Date	<b>24 Nov 2021, 18:40:25</b>
Transaction Number	<b>71531590 (CC10006)</b>	Queue Number	<b>312309</b>

Chassis Number	<b>1ZVHT80N485208768</b>
Engine Number	
Vehicle Class	<b>Car</b>
Manufacturer	<b>Ford</b>
Model	<b>Mustang</b>
Model Year	<b>2008</b>
Color	<b>Grey</b>
Mileage	<b>86944 Miles</b>
Fuel Type	<b>Petrol</b>
No. Of Cylinders	<b>6</b>
Specification	<b>USA Imported</b>

# Test Certificate

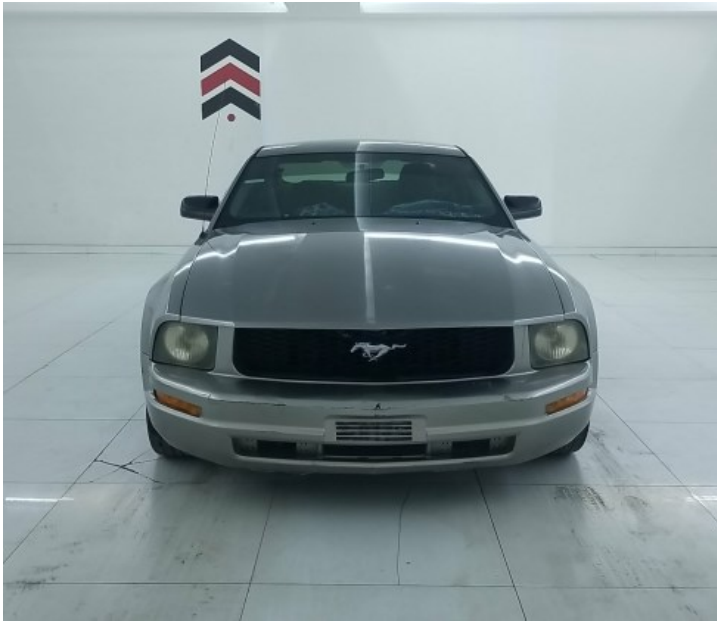
DEFECT	REMARKS	
<b>01 Tires and Rims Condition</b>		<b>الاطارات</b>
01.A Front Tyre	BOTH SIDE 2018 CRACKED	الاطار الامامي
01.B Rims Condition	RIMS HAVE MINOR SCRATCHES	حالة الجنوط
01.C Rear Tyre	BOTH SIDE 2014/2017 EXPIRED & CRACKED	الاطار الخلفي
<b>02 Seats Condition</b>		<b>المقاعد</b>
02.A Seat Belt	OK	حزام الأمان
02.B Seat Condition	PORTION DAMAGED	حالة المقاعد
<b>03 Body</b>		<b>جسم المركبة</b>
03.A Fenders	REAR BOTH SIDE REPAIRED & REPAINTED	مدكار
03.B Paint	PORTION REPAIRED, REPAINTED & DENTS, SCRATCHES ON BODY & PORTION FADED	الصبغ
03.C Bumper	REPAINTED	دعامية
03.D Roof	LEFT SIDE ROOF RAIL REPAINTED	السقف
03.E Trunk	REPAINTED & PORTION FADED	صندوق
03.F Floor	REAR BOTH SIDE QUATER PANEL, WHEEL ARCH, RUNNING BOARD REPAIRED	الارضية
<b>04 Interior Condition</b>		<b>الحاله الداخليه</b>

DEFECT	REMARKS	
04.A AC Condition	NOT COOLING	المكيف
04.B Dash Board	PORTION DAMAGED	لوحة القيادة
04.C Mirror	LEFT SIDE INNER COVER DAMAGED & LOOSED	المرابا
<b>05 Transmission Condition</b>		<b>الجير</b>

05.A Gear Box	GEAR SHIFTING LEVER CONSOLE BOX DUST COVER MISSING	الجير
05.B Road Test	NOT CHECK	فحص علي الطريق
<b>06 Chassis Condition</b>		<b>الشاسيه</b>

06.A Chassis	REAR LEFT SIDE REPAIRED, FRONT LEFT SIDE INNER & REAR BOTH SIDE JOINT DENT	الشاسيه
<b>07 Engine Condition</b>		<b>المحرك</b>
07.A Engine Condition	MINOR OIL LEAK	حالة المحرك
<b>08 Suspension System</b>		<b>ممتص الصدمات</b>

08.A Arms	FRONT LOWER ARMS BUSHES CUT	ازرع
<b>09 Lights</b>		<b>الاضاءة</b>
09.A Head Light	OK & LENS SLIGHTLY FADED	الاضاءة الرئيسية
09.B Indicator & Hazard light	REAR LEFT SIDE NOT WORKING	الاشارات

09.C Tail Light	REAR RIGHT SIDE PARK LIGHT NOT WORKING	الانارة
09.D Brake Light	LEFT SIDE NOT WORKING	نور الفرامل
09.E Warning Light	WARNING LIGHT ON IN DISPLAY	ضوء تحذير
<b>10 Wipers and Arms</b>		<b>المساحات</b>

10.A Wiper Arm & Blade	WORN OUT	ازرع المساحات والشفرات
<b>11 Brake Condition</b>		<b>الفرامل</b>
11.A Disc&Drum	GETTING RUSTY	دسك ووطنابير الفرامل
