## TEST CERTIFICATE

Chassis Number	<b>1GCNC9EA6BZ300515</b>
Engine Number	
Vehicle Class	<b>Car</b>
Manufacturer	<b>Chevrolet</b>
Model	<b>Silverado</b>
Model Year	<b>2011</b>
Color	<b>Black</b>
Mileage	<b>202711 Km</b>
Fuel Type	<b>Petrol</b>
No. Of Cylinders	<b>8</b>
Specification	<b>GCC Specification</b>

# Test Certificate

Certificate Number :	5-TAS-2022-17731223		
Inspection Date :	28-09-2022		
Certificate Print Date :	28-09-2022		
Services :	Registration Test		
Vehicle Testing Partner :	Tasjeel		
Vehicle Testing Center :	Tasjeel Al Aweer		
Total Time Taken :	12 min 3 sec		
Appointment Ref Number :	--		
Start Time :	8:09	End Time :	8:21
Lane :	03	Token No. :	105
Attempt :	1	Prints No. :	1

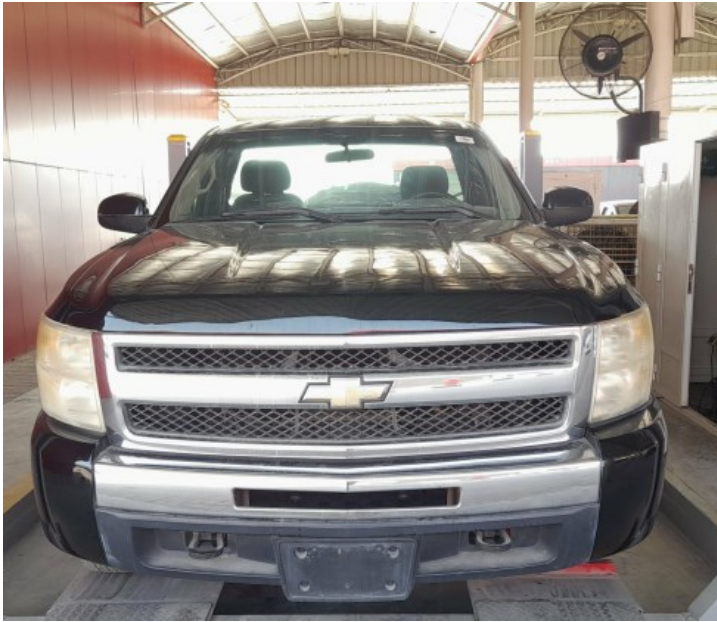
DEFECT	REMARKS	
<b>01 Body</b>		<b>جسم المركبة</b>
01.A Fenders	REFITTED	مدكار
01.B Paint	BODY REPAINTED , PORTION REPAIRED MINOR DENTS SCRATCHES	الصبغ
01.C Bonnet	REFITTED	غطاء المحرك
01.D Bumper	MISALIGN	دعامية
01.E Sign of front accident		وجود مؤشر لحادث في المقدمة
<b>02 Tires and Rims Condition</b>		<b>الاطارات</b>
02.A Rear Tyre	BOTH SIDE 2017 CRACKED , EXPIRED	الاطار الخلفي
02.B Front Tyre	BOTH SIDE 2018	الاطار الامامي
<b>03 Transmission Condition</b>		<b>الجير</b>
03.A Visual Gear Box Condition	JERKING & REFITTED	حالة الجير النظري
03.B Road Test	NOT CHECK	فحص علي الطريق
<b>04 Interior Condition</b>		<b>الحاله الداخليه</b>
04.A Mirror	CENTER GLASS CRACKED	المرايا
04.B Door Panel	LEFT SIDE LOOSE	لوحة بطانة الباب

DEFECT	REMARKS	
04.C AC Condition	OK	المكيف
04.D Dash Board	PORTION DAMAGED	لوحة القيادة
04.E Power Window Switch	SWITCH COVER LOOSE	مفتاح النافذه
<b>05 Engine Condition</b>		<b>المحرك</b>
05.A Visual Engine Condition	SIGN MINOR OIL LEAK & REFITTED	حالة المحرك النظرى
<b>06 Suspension System</b>		<b>ممتص الصدمات</b>
06.A Ball Joint	BOOT CUT	مفصل كروي
06.B Shock Absorber	MINOR LEAK	ممتص الصدمات
06.C Arms	LOWER ARM BUSHES CRACKED	ازرع
<b>07 Steering Condition</b>		<b>المقود</b>
07.A Tie Rod End	BOOT CUT	مؤخرة الرودادت
<b>08 Lights</b>		<b>الاضاءة</b>
08.A Head Light	LENS FADED	الاضاءة الرئيسية
08.B Brake Light	LEFT SIDE LOWER BULB NOT WORKING	نور الفرامل
08.C Tail Light	LEFT SIDE CRACKED	الانارة
<b>09 Chassis Condition</b>		<b>الشاصي</b>
09.A Chassis	FRONT LEFT SIDE CHASSIS REPAIRED,MINOR BEND ,CHASSIS FRAME RUST PROOFED,GETTING RUSTY	الشاسيه
