TEST CERTIFICATE

Site Number	840-Emirates Auctions	Transaction Date	15 Aug 2022, 10:51:54
Transaction Number	53684297 (CC10008)	Queue Number	312309

Chassis Number	2C3CCABG3KH617870
Engine Number	
Vehicle Class	Car
Manufacturer	Chrysler
Model	300
Model Year	2019
Color	Black
Mileage	33664 Miles
Fuel Type	Petrol
No. Of Cylinders	6
Specification	USA Imported

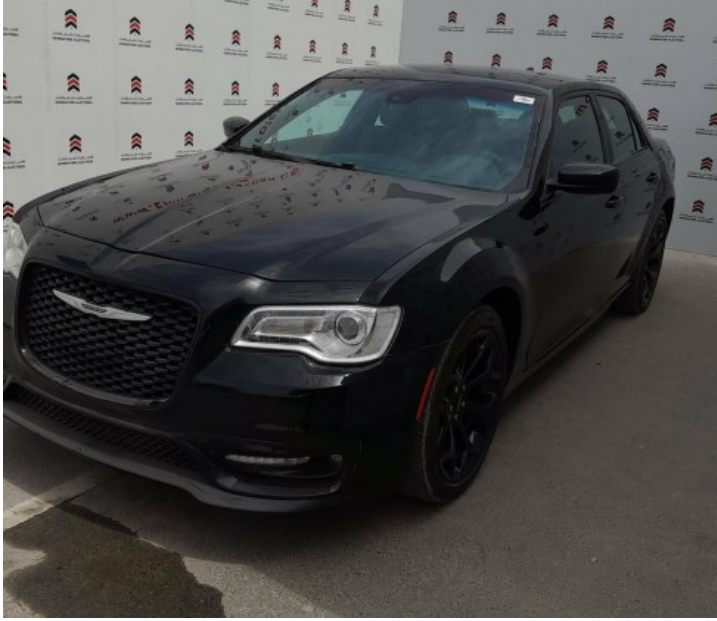
DEFECT	REMARKS	
01 Interior Condition		الحاله الداخليه
01.A AC Condition	OK	المكيف
01.B Air Bag	DAMAGED	وسائد هوائية
01.C Dash Board	CRACKED	لوحة القيادة
02 Tires and Rims Condition		الاطارات
02.A Front Tyre	BOTH SIDE 2019 CRACKED	الاطار الامامي
02.B Rear Tyre	BOTH SIDE 2019 CRACKED	الاطار الخلفي
03 Body		جسم المركبة
03.A Sign of back accident		وجود مؤشر لحادث في الخلف
03.B Other	FRONT FENDER FRAME, RADITOR SUPPORT , BULK HEAD,BUMPER FRAME REPAIRED, BEND	اخرى
03.C Floor	BACK PANEL QUARTER PANEL CONPARTMENT FLOOR REPAIRED.FLOOR COVERED CHECKED ONLY VISIBLE AREA	الارضية
03.D Trunk	REPAIRED REFITTED REPAINTED.	صندوق
03.E Paint	BODY TOTALY REPAINTED REPAIRED , MINOR DENT,SCRATCHES	الصبغ
03.F Bonnet	REFITTED	غطاء المحرك
03.G Sign of front accident		وجود مؤشر لحادث في المقدمة

DEFECT	REMARKS	
03.H Sign of side accident		وجود مؤشر لحادث في الجانب
03.I Doors	ALL DOORS REFITTED REPAINTED REPAIRED.	أبواب
03.J Fenders	FRONTBOTH SIDE REFITTED	مدكار
03.K Roof	REPAIRED REPAINTED.	السقف
04 Chassis Condition		الشاصي
04.A Chassis	FRONT BOTH SIDE CHASSIS END & REAR BOTH SIDE CHASSIS EXTENSION REPAIRED, BEND, DENT	الشاسيه
05 Suspension System		ممتص الصدمات
05.A Suspension Subframe	FRONT & REAR SUSPENSION ASSEMBLY REFITTED.	
06 Transmission Condition		الجير
06.A Visual Gear Box Condition	REFITTED.	حالة الجير النظري
06.B Road Test	NOT CHECK	فحص علي الطريق
07 Seats Condition		المقاعد
07.A Seat Condition	FRONT RIGHT SIDE SEAT COVER DAMAGED	حالة المقاعد
08 Lights		الاضاءة
08.A Warning Light	WARNING LIGHT ON IN DISPLAY	ضوء تحذير
09 Engine Condition		المحرك
09.A Visual Engine Condition	REFITTED.	حالة المحرك النظري
