## TEST CERTIFICATE

Site Number	<b>840-Emirates Auctions</b>	Transaction Date	<b>19 Jan 2023, 17:01:06</b>
Transaction Number	<b>55900390 (CC10010)</b>	Queue Number	<b>657732</b>

Chassis Number	<b>JHMCP36788C400959</b>
Engine Number	
Vehicle Class	<b>Car</b>
Manufacturer	<b>Honda</b>
Model	<b>Accord</b>
Model Year	<b>2008</b>
Color	<b>White</b>
Mileage	<b>508635 Km</b>
Fuel Type	<b>Petrol</b>
No. Of Cylinders	<b>6</b>
Specification	<b>GCC Specification</b>

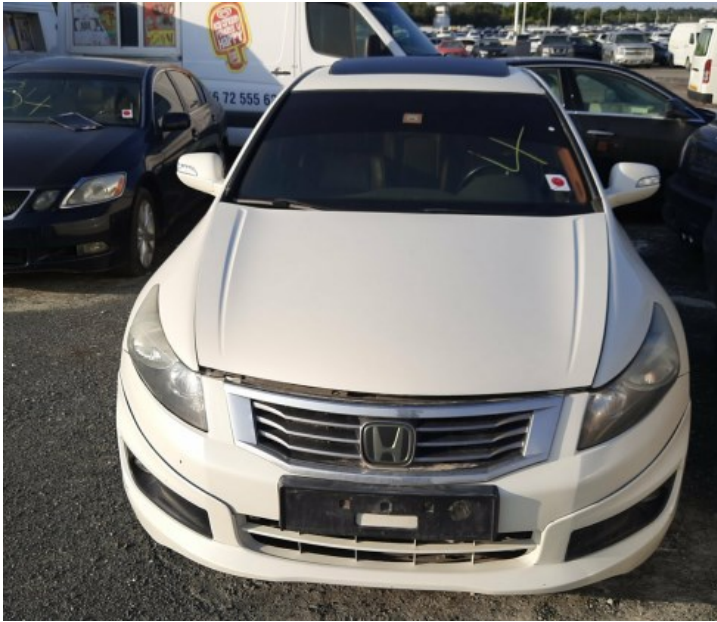
DEFECT	REMARKS	
<b>01 Body</b>		<b>جسم المركبة</b>
01.A Fenders	FRONT REFITTED	مدكار
01.B Sign of front accident		وجود مؤشر لحادث في المقدمة
01.C Other	MISALIGN,PORTION DAMAGED,FRONT BUMPER FRAME ,FENDER FRAME ,BULKHEAD ,RADIATOR SUPPORT REPAIRED.	اخرى
01.D Paint	BODY REPAIRED,REPAINTED,MINOR DENT ,SCRATCHES ,PORTION FADED	الصبغ
01.E Bonnet	REFITTED	غطاء المحرك
<b>02 Interior Condition</b>		<b>الحاله الداخليه</b>
02.A Roof Ceiling	PORTION LOOSE	بطانه السقف
02.B AC Condition	OK	المكيف
02.C Roof Light	LEFT SIDE DAMAGED	أنارة السقف
02.D Sunroof	NOT WORKING	فتحت سقف
02.E Power Window Switch	MAIN SWITCH PANEL LOOSE,REAR RIGHT SIDE NOT WORKING OWN SWITCH	مفتاح النافذه
<b>03 Chassis Condition</b>		<b>الشاسيه</b>
03.A Chassis	FRONT BOTH SIDE CHASSIS END REPAIRED,LEFT SIDE DENT ,APRON STUD MOUNT AREA CRACKED .	الشاسيه

DEFECT	REMARKS	
<b>04 Tires and Rims Condition</b>		<b>الاطارات</b>
04.A Rims Condition	RIMS DENT SCRATCHES	حالة الجنوط
04.B Front Tyre	BOTH SIDE 2022	الاطار الامامي
04.C Rear Tyre	BOTH SIDE 2022	الاطار الخلفي
<b>05 Seats Condition</b>		<b>المقاعد</b>
05.A Seat Condition	DRIVER SEAT BACK COVER MISSING	حالة المقاعد
<b>06 Lights</b>		<b>الاضاءة</b>
06.A Warning Light	WARNING LIGHT & WARNING MESSAGE ON DISPLAY.	ضوء تحذير
<b>07 Suspension System</b>		<b>ممتص الصدمات</b>
07.A Shock Absorber	LEAK .	ممتص الصدمات
07.B Arms	LOWER ARM BUSHES CRACKED .	ازرع
<b>08 Transmission Condition</b>		<b>الجير</b>
08.A Road Test	NOT CHECK	فحص علي الطريق
08.B Visual Gear Box Condition	OIL LEAK REFITTED .	حالة الجير النظرى
<b>09 Engine Condition</b>		<b>المحرك</b>
09.A Visual Engine Condition	OIL LEAK ,REFITTED .	حالة المحرك النظرى
