## **TEST CERTIFICATE**

Chassis Number WDDHF5EB3DA740835

Manufacturer Mercedes

Model E 300

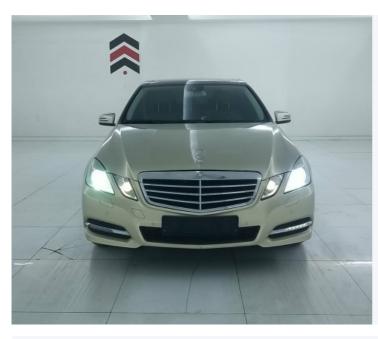
03.A Chassis

FRONT LEFT SIDE CHASSIS REPAIRED
