TEST CERTIFICATE

Site Number	840-Emirates Auctions	Transaction Date	18 Sep 2022, 13:19:58
Transaction Number	98089494 (CC10009)	Queue Number	592238

Chassis Number	4M2EU47E08UJ03291
Engine Number	
Vehicle Class	Car
Manufacturer	Mercury
Model	Mountaineer
Model Year	2008
Color	Maroon
Mileage	353983 Km
Fuel Type	Petrol
No. Of Cylinders	6
Specification	GCC Specification

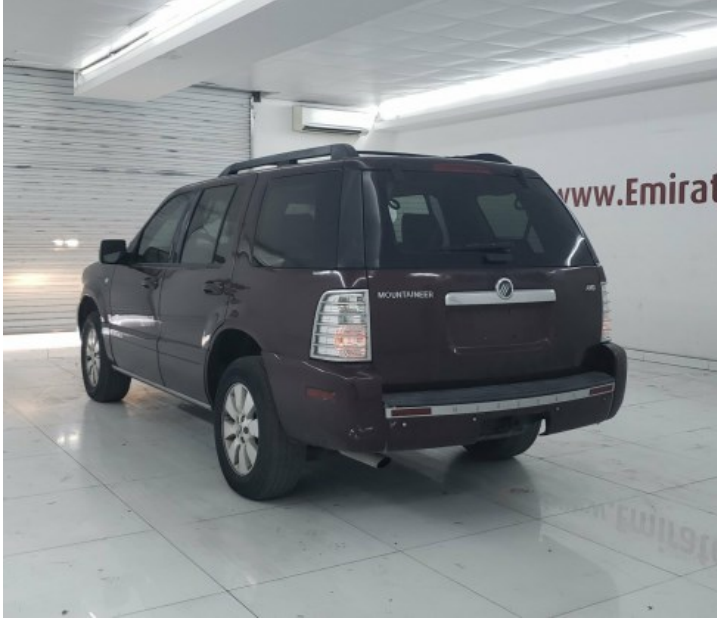
DEFECT	REMARKS	
01 Interior Condition		الحاله الداخليه
01.A Roof Ceiling	PORTION LOOSE	بطانه السقف
01.B Door Panel	PORTION DAMAGED	لوحة بطانه الباب
01.C AC Condition	LOW COOLING , GRILL DAMAGED	المكيف
01.D Sun Visor	RIGHT SIDE GLASS COVER MISSING	حاجب الشمس
01.E Steering Wheel and control buttons	WORN OUT	عجلة القيادة وازرار التحكم
02 Body		جسم المركبة
02.A Trunk	PORTION REPAIRED,REPAINTED,REFITTED	صندوق
02.B Fenders	FRONT FIBER PAINT CANNOT CHECK	مدكار
02.C Paint	BODY PORTION REPAIRED, REPAINTED,MINOR DENT,SCRATCHES & PORTION FADED	الصبغ
02.D Door Handle &Lock	REAR RIGHT SIDE INNER HANDLE DAMAGED	مقابض الأبواب والأقفال
02.E Other	FRONT FENDER FRAME ,BULK HEAD,BUMPER FRAME RADIATOR SUPPORT REPAIRED & REAR RIGHT SIDE QUATER PANEL REPAIRED	اخرى
02.F Sign of front accident		وجود مؤشر لحادث في المقدمة
03 Transmission Condition		الجير

DEFECT	REMARKS	
03.A Road Test	NOT CHECK	فحص علي الطريق
03.B Visual Gear Box Condition	OIL LEAK,REFITTED	حالة الجير النظرى
03.C Gear Box Mount	MOUNT RUBBER CUT	كرسي الجير
04 Tires and Rims Condition		الاطارات

04.A Front Tyre	LEFT SIDE 2020 & RIGHT SIDE 2018 CRACKED	الاطار الامامي
04.B Rear Tyre	BOTH SIDE 2018 & CRACKED	الاطار الخلفي
05 Engine Condition		المحرك

05.A Visual Engine Condition	OIL LEAK,REFITTED	حالة المحرك النظرى
05.B Mount	MOUNT RUBBER CUT	كرسي
05.C Smoke	WHITE SMOKE	دخان
06 Suspension System		ممتص الصدمات

06.A Ball Joint	BOOT CUT	مفصل كروي
06.B Other	STABILIZER LINK BOOT CUT	اخرى
06.C Arms	LOWER ARM BUSHES CUT	ازرع
07 Steering Condition		المقود
07.A Tie Rod End	BOOT CUT	مؤخرة الرودادات
08 Lights		الاضاءة

08.A Warning Light	WARNING LIGHT ON DISPLAY	ضوء تحذير
09 Seats Condition		المقاعد
09.A Seat Condition	PORTION DAMAGED	حالة المقاعد
10 Chassis Condition		الشاسي

10.A Chassis	FRONT RIGHT SIDE CHASSIS END DENT & LEFT SIDE SLIGHTLY DEND	الشاسيه
