| Queue Number | 2836153 | Transaction Date | 05 Oct 2026, 12:32:29 |
| Site Name | 840 - Emirates Auctions | Transaction Number | 83416543 (CC10010) (CC10010) |
| | | <b>Vehicle Details</b> | |

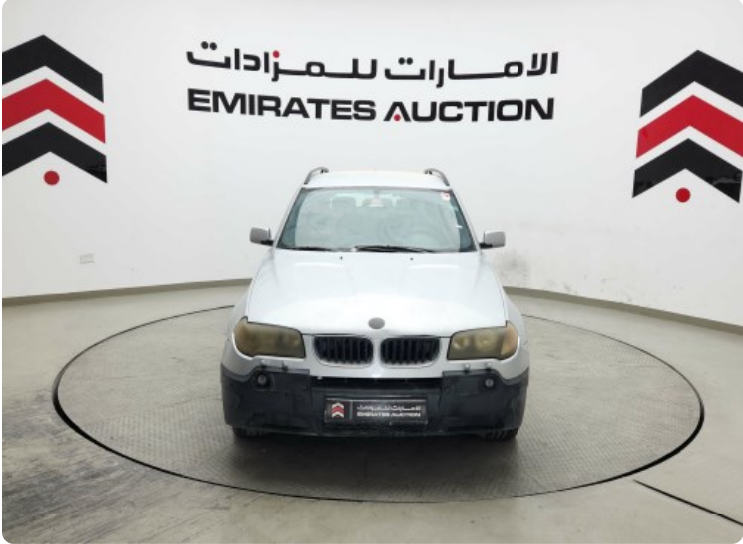
| | | Chassis Number | WBAPA91064***** |
| | | Specification | GCC Specification |
| | | Make | BMW |
| | | Model | X3 |
| | | Model Year | 2004 |
| | | Color | Silver |
| | | Fuel Type | Petrol |
| | | No. Of Cylinders | 6 |
