TEST CERTIFICATE

Site Number	840-Emirates Auctions	Transaction Date	06 Oct 2021, 17:49:24
Transaction Number	54121661 (CC10006)	Queue Number	312309

Chassis Number	6T1BK42K78X912684
Engine Number	
Vehicle Class	Car
Manufacturer	Toyota
Model	Aurion
Model Year	2008
Color	Silver
Mileage	195026 N/A

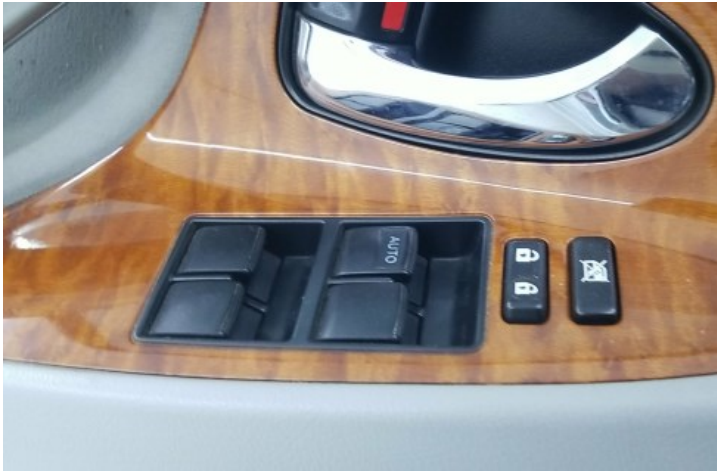
DEFECT	REMARKS	
01 Tires and Rims Condition		الاطارات
01.A Front Tyre	BOTH 2018	الاطار الامامي
01.B Rear Tyre	BOTH SIDE 2021/2019	الاطار الخلفي
02 Interior Condition		الاجزاء الداخلية
02.A AC Condition	OK	المكيف
02.B Other	CONSOLE BOX COVER LEATHER CUT	اخرى
03 Body		جسم المركبة
03.A Paint	BODY PORTION REPAINTED,REPAIRED,MINOR DENT,SCRATCHES	الصبغ
03.B Doors	LEFT SIDE DOOR REPAINTED	أبواب
03.C Fenders	FRONT & REAR LEFT FENDER REPAINTED	مدكار
03.D Bonnet	REPAIRED & REPAINTED,REFITIED&SHOCK STAND WEAK	غطاء المحرك
03.E Bumper	REPAINTED,MISALIGN	دعامية
03.F Other	FRONT BULK HEAD ,FENDER FRAME REPAIRED	اخرى
03.G Floor	UNDER BODY RUST PROOFED	الارضية
04 Engine Condition		المحرك
04.A Other	OK	اخرى
05 Transmission Condition		الجير
05.A Gear Box	OK	الجير

DEFECT	REMARKS	
06 Wipers and Arms		المساحات
06.A Other	WORN OUT	اخرى
07 Suspension System		ممتص الصدمات
07.A Arms	FRONT BOTH LOWER ARM BUSHES MINOR CRACKED	ازرع
08 Chassis Condition		الشاسي
08.A Chassis	OK	الشاسيه
09 Steering Condition		المقود
09.A Steering Oil	SIGN OF OIL LEAK	زيت المقود
