## TEST CERTIFICATE

Chassis Number	<b>WP1ZZZ92ZGLA78523</b>
Engine Number	
Vehicle Class	<b>Car</b>
Manufacturer	<b>Porsche</b>
Model	<b>Cayenne</b>
Model Year	<b>2016</b>
Color	<b>Black</b>
Mileage	<b>132073 Km</b>
Fuel Type	<b>Petrol</b>
No. Of Cylinders	<b>6</b>
Specification	<b>GCC Specification</b>

# Test Certificate

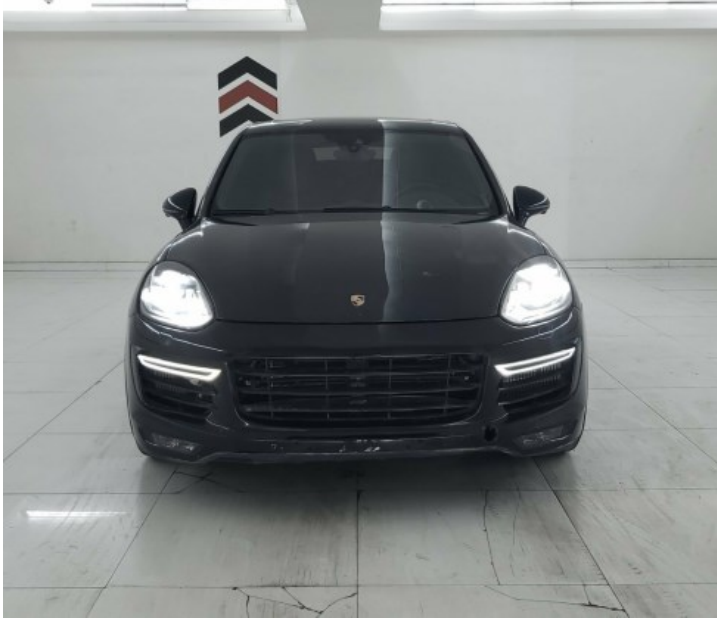
DEFECT	REMARKS	
<b>01 Body</b>		<b>جسم المركبة</b>
01.A Sign of front accident		وجود مؤشر لحادث في المقدمة
01.B Paint	REPAINTED PORTION REPAIRED MINOR DENTS SCRATCHES ON BODY	الصبغ

01.C Floor	UNDER FLOOR CHASSIS FULLY COVERED CHECKED VISIBLE AREA	الارضية
01.D Fenders	FRONT BOTH SIDE PORTION REPAIRED, REPAINTED & REFITTED, RIGHT SIDE FENDER SKIRT LOOSE	مدكار

01.E Doors	FRONT LEFT SIDE PORTION REPAIRED,REPAINTED	أبواب
01.F Bonnet	PORTION REPAIRED,REPAINTED & REFITTED, SHOCKS WEAK	غطاء المحرك
01.G Trunk	PORTION REPAIRED,REPAINTED	صندوق

01.H Other	FRONT BUMPER FRAME BULK HEAD FENDER FRAME RADIATOR SUPPORT REPAIRED	اخرى
01.I Pillars	RIGHT SIDE B PILLAR INNER COVER LOOSE	القوائم
<b>02 Interior Condition</b>		<b>الحالة الداخلية</b>
